CALIFORNIA PUBLIC UTILITIES COMMISSION
Safety and Enforcement Division
Wildfire Safety and Enforcement Branch

Incident Investigation Report

Incident Number: E20211223-01 (Brewer Fire)

Regulated Utility Facilities Involved: Higgins 1103 12kV Distribution Circuit

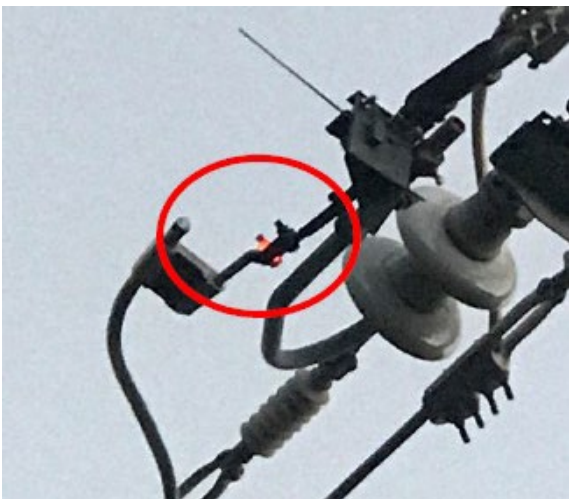
vegetation below. The investigation at the Incident Pole revealed a hot glowing bolt at the top of the power pole. Other possible causes (lightning, children, vehicles, and smoking) were excluded, which left the most probable cause of the fire as the electrical distribution equipment.⁴

Figure 2: Glowing bolt identified in 20 Day Report.

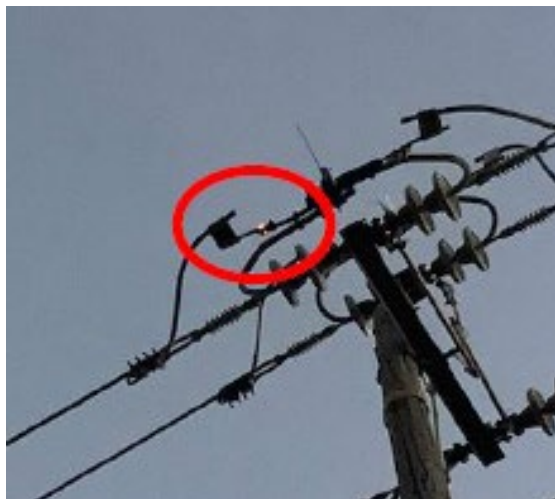
Figure 3: Glowing bolt and switch equipment from 20 Day Report.

At 2030 – 2045 hours, the PG&E supervisor called in a repair crew to fix the jumper on the Incident Pole. By 2300 hours, the repair crew arrived on site, the troubleman deenergized the line, and the repair crew began working.

Emergency repair work was completed on July 8, 2021 at 0100 hours, at which time the troubleman reenergized the line. At 0400 hours a notification was created to request the replacement of the switch 2295 at the Incident Pole, and at 0920 hours a notification was created calling for the replacement of the pole and switch equipment.

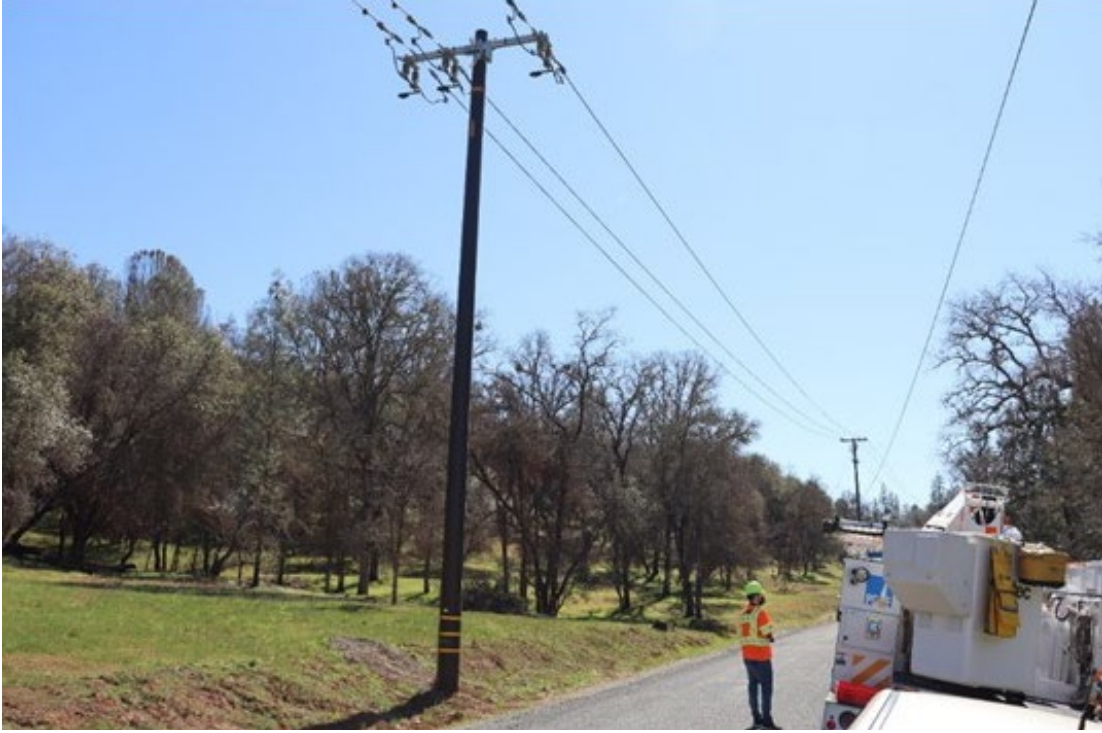
Figure 4: Incident Location and Incident Pole on Iron Horse Rd. in Grass Valley, CA.

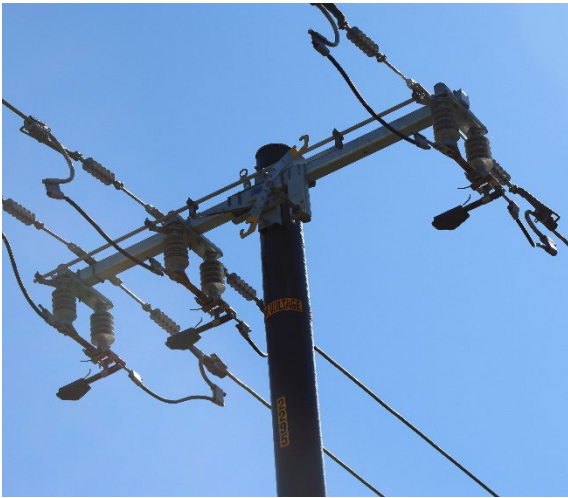
Figure 5: New equipment on top of pole.

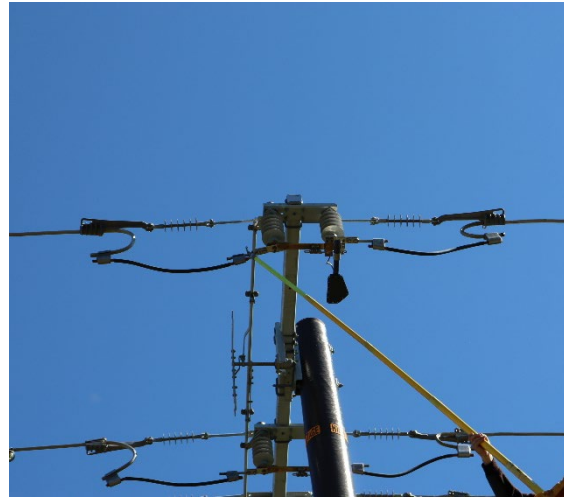
Figure 6: Troublemaker identifying new paddle jumper.

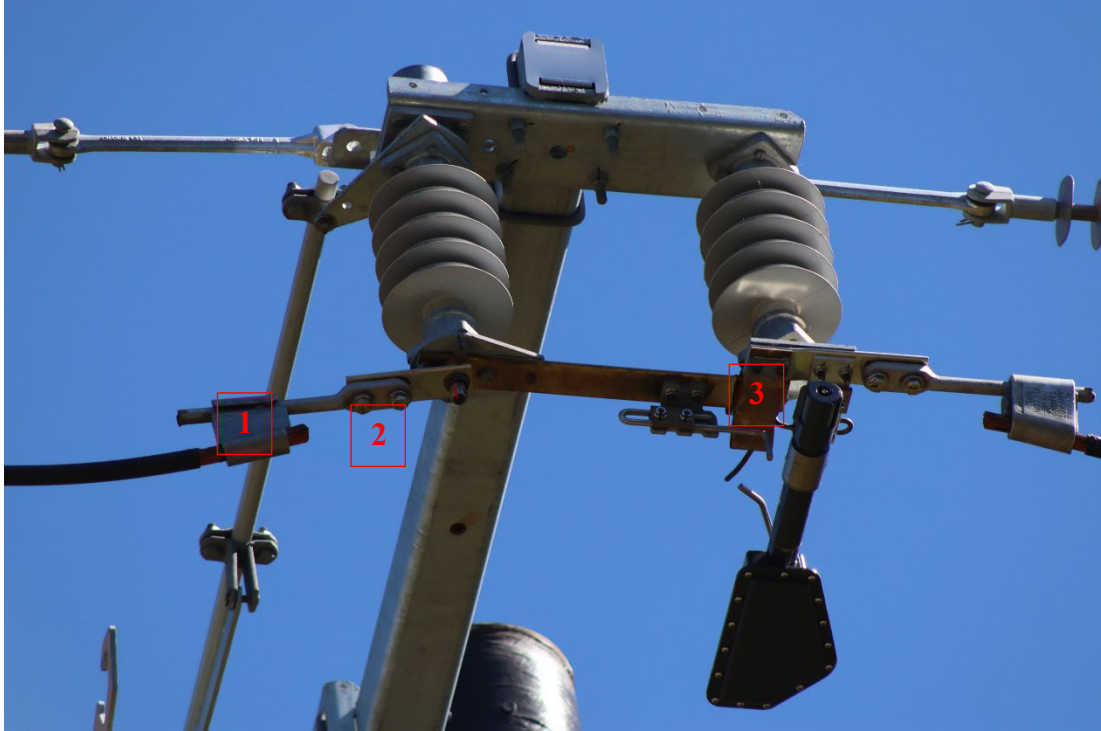
Figure 7: Close-up of new wedge connector (1), bolts on new paddle jumper (2), and switch equipment (3).

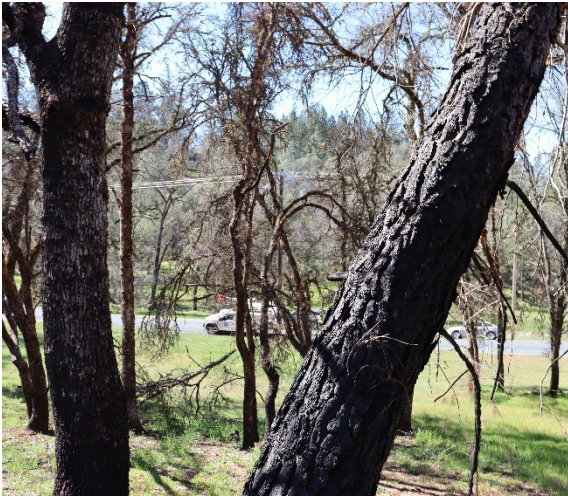
Figure 8: Burned trees looking towards Incident Pole.

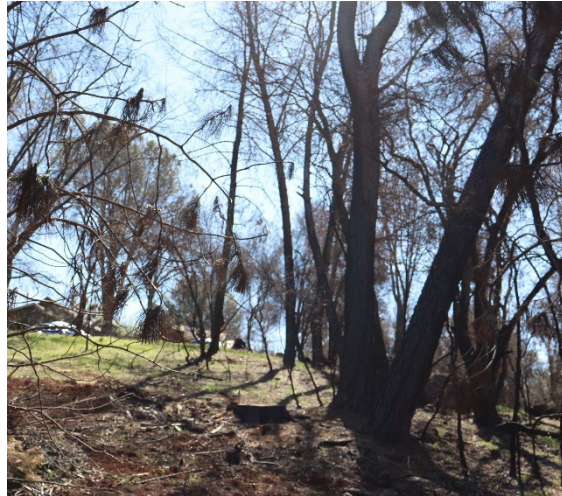
Figure 9: Burned trees near property structures.

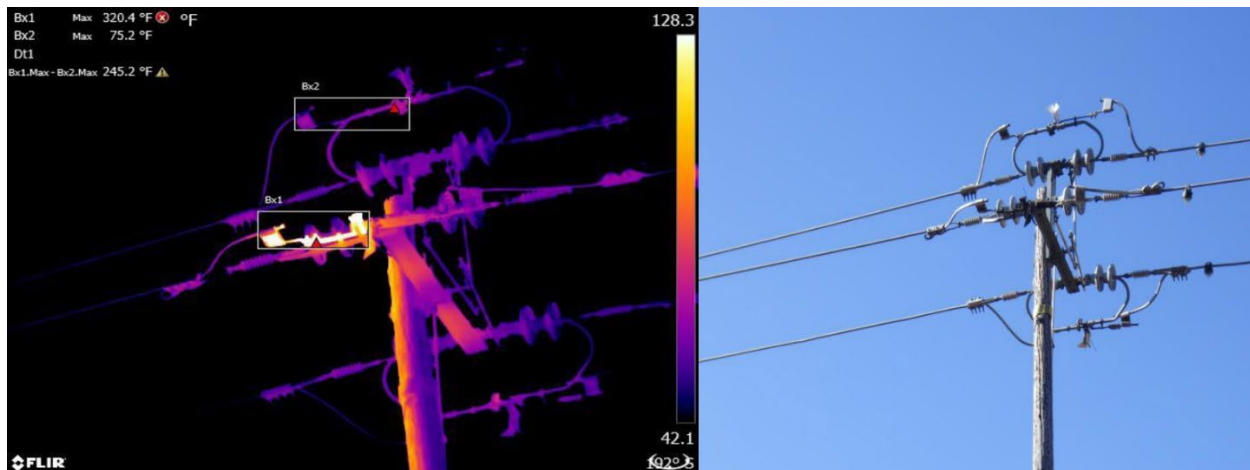
The Forward Looking Infrared (FLIR) image attached to the October 29, 2020 IR inspection report (Figure 10) showed a hot spot temperature of 320.4°F at the overheating jumper connection, and a normal temperature of 75.2°F at a normal jumper connection, which equates to a 245.2°F temperature differential (ΔT).¹⁴ The image shows an elevated temperature which is not visible to the naked eye. PG&E Procedure TD-2022P-01 provides a table which indicates priority levels for overheating equipment based on the absolute hot spot temperature (Figure 11).¹⁵

Figure 10: FLIR image from October 29, 2020 inspection of Switch 2295 showing maximum and differential temperature between two jumper connections. The temperature differential measured is 245.2°F.

Based on PG&E Procedure TD-2022P-01, a ΔT greater than 108°F requires an EC Tag with Priority B and requires repair work to be completed within 30 days. However, EC Tag #119998009 was created from this IR inspection as Priority E and required the repair work be completed within 180 days instead of the required 30 days per PG&E Procedure TD-2022P-01.

PG&E explained in its Event Analysis Report (EAR) for the Brewer Fire that when the EC Tag #119998009 form was created, the clerk annotated the notification with an incorrect ΔT and initially assigned an incorrect due date for the tag Priority B due 90 days from the inspection.¹⁶ The EAR further explains that a PG&E gatekeeper, who was responsible for reviewing the work of the clerk who created the EC Tag that day, downgraded EC Tag #119998009 to be Priority E. According to the EAR, the gatekeeper annotated that the hot spot temperature was 128.3°F and that the ΔT was 57.2°F . The gatekeeper misidentified the FLIR image's temperature scale (the vertical bar on the right side of the display on Figure 10) for actual temperature readings. According to the table shown in Figure 11, this ΔT would require a Priority E tag with a due date of 180 days. The due date for EC Tag #119998009 was set for April 28, 2021, six months after the notification was created.

Since EC Tag #119998009 was downgraded to Priority E and was not expected to be completed by its due date, April 28, 2021, it was subject to a FSR on March 12, 2021. This visual inspection, that was performed without IR cameras, concluded that the equipment was in good condition and added comments to the EC tag stating "Ok to cancel tag. Switch is in good condition." On March 31, 2021 a PG&E gatekeeper subsequently cancelled EC Tag #119998009.¹⁷ On July 7, 2021, the PG&E troubleman and CAL FIRE investigator who responded to the Brewer Fire observed a glowing red bolt on the paddle jumper in the location that the IR inspection identified an elevated temperature on October 29, 2020.

GO 95 Rule 31.1's requirement to use accepted good practices extends to requiring regulated utilities to follow their internal procedures, as those are accepted as good practices by the utility. PG&E Procedure TD-2022P-01 requires that elevated temperature differentials at connectors and switches greater than 108°F ΔT require an EC Tag with Priority B and require repair work to be completed within 30 days. However, EC Tag #119998009 was given Priority E and was required to be completed within 180 days when it should have been given Priority B and completed within 30 days of identification, based on its temperature differential reading of 245.2°F. PG&E's clerk and gatekeeper who created the EC Tag did not understand how to read the hot spot temperature on the FLIR image, which is the output of the IR camera.

This failure to read the FLIR directly led to the EC Tag being assigned the wrong priority for repair work for a distribution facility with a condition noted as "severe" per PG&E Procedure TD-2022P-01 "Infrared (IR) Inspections of Electrical Distribution Facilities. PG&E's failure to comply with the utility's internal procedures for repairing equipment hot spot temperatures is a violation of GO 95 Rule 31.1.

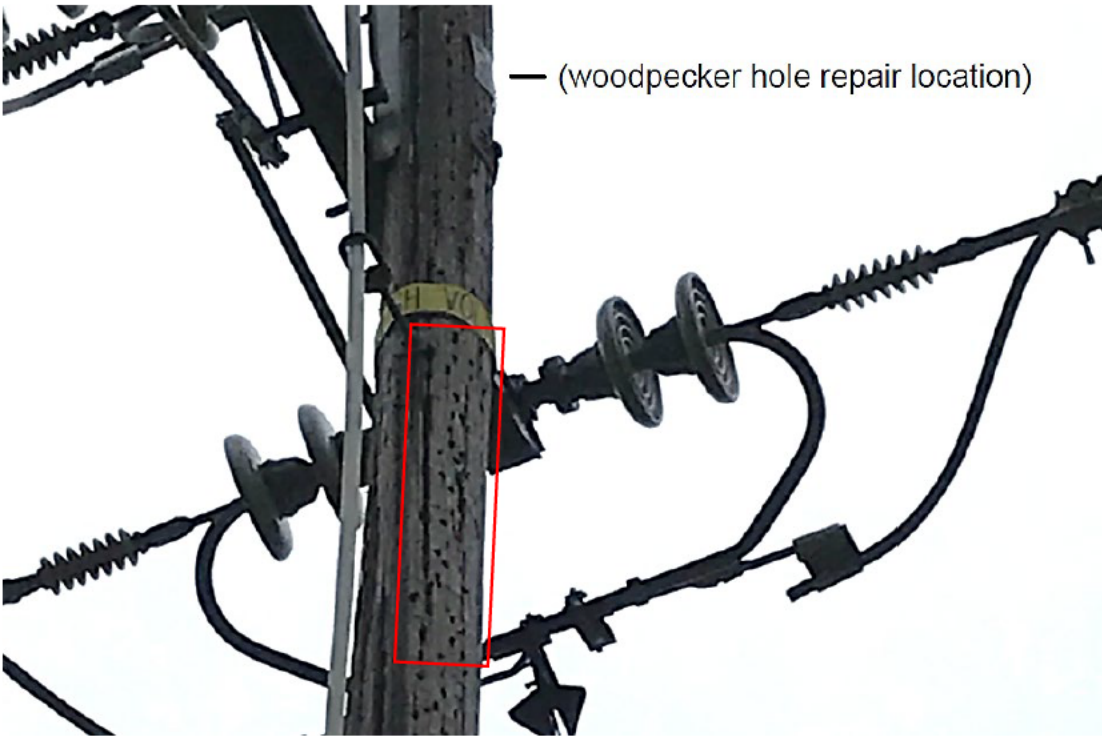
A photograph provided by PG&E in response to SED's second Data Request showing the Incident Pole after the single large hole repair work performed under EC Tag #114668140 also shows several starter holes less than 3 inches in diameter (Figure 12).²⁸

Figure 12: Incident Pole with repair of the single large woodpecker hole indicated and showing the excessive woodpecker damage which was noted after that repair.

As quoted above, PG&E Procedure TD-2305M-JA02 states that multiple starter holes totaling over 9 inches in diameter in a single 1-foot vertical section, requires pole replacement rather than repair, and Figure 12 shows the completed repair work for EC Tag #114668140. Figure 12 also shows what appears to be a cluster of starter holes totaling more than 9 inches in diameter in a single 1-foot vertical section on the Incident Pole. SED finds that, according to PG&E Procedure TD-2305M-JA02, the Incident Pole should have been replaced, rather than repaired, under EC Tag #114668140. This is further evidenced by the fact that 2 months after the repair of the single large woodpecker hole, the pole was scheduled for replacement by PG&E under EC Tag #116854528.

GO 95 Rule 31.1's requirement to use accepted good practices extends to requiring regulated utilities to follow their internal procedures, as those are accepted as good practices by the utility. PG&E Overhead Inspection Job Aid, Procedure TD-2305M-JA02, states that utility poles with woodpecker damage must be replaced, not repaired, if the sum of the diameters of the woodpecker starter holes is greater than 9 inches in a given one-foot vertical section. The photo provided by PG&E showing the repair work which patched a single, large woodpecker hole on January 31, 2021 also shows excessive woodpecker damage which meets the criteria to require the pole be replaced, rather than repaired. This is further evidenced by the fact that within two months of the repair work being completed under EC Tag #114668140, another PG&E inspection called for the pole to be replaced under EC Tag #116854528.

Based on the excessive woodpecker damage to the Incident Pole, PG&E should have replaced, rather than repaired, the pole under EC Tag #114668140. PG&E's failure to comply with the utility's internal procedures for replacing poles with excessive woodpecker damage is a violation of GO 95 Rule 31.1.
