#### CALIFORNIA PUBLIC UTILITIES COMMISSION Safety and Enforcement Division Electric Safety and Reliability Branch

#### **Incident Investigation Report**

Incident Number: E 20150916-01

**Utility:** Pacific Gas and Electric Company (PG&E)

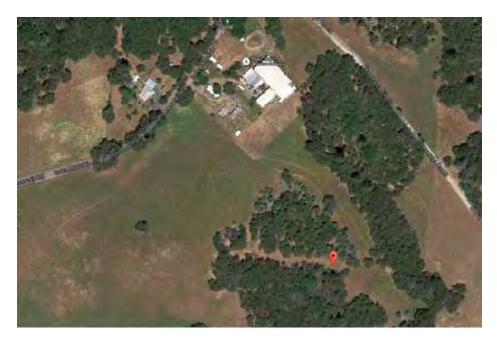
On September 9, 2015 at approximately 1446 hours, a 44-foot gray pine tree contacted an overhead conductor of PG&E's Electra 1101 12 kV circuit located in the vicinity of the residence property at 17704 Butte Mountain Road in the city of Jackson in Amador County (see figure 1), starting the "Butte Fire". The fire burned 70,868 acres, destroyed 921 structures (549 homes, 268 outbuildings, and 4 commercial properties), damaged 44 structures, and resulted in two civilian "indirect" fatalities and one injury. Both death victims were residents of Calaveras County who refused to evacuate the area as recommended by local authorities. The coroner's reports indicated that the cause of death for both victims was "consumption by fire (residential conflagration)". The fire caused power interruptions to 3644 customers for 16,651,071 customer minutes, 6377 customers for 10,053,920 customer minutes and 4246 customers for 23,519,468 customer minutes. The 12 kV conductor did not fail and fall to the ground.

Figure 1: Ignition point/location

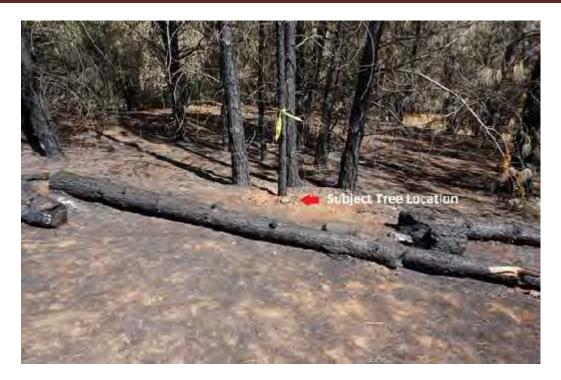
On September 18, 2015, SED met with CAL FIRE Battalion Chief Gianni Muschetto, CAL FIRE Attorney David Wiseman, and and and and of PG&E at the incident location. SED observed that the subject tree had been removed, and a section of the 12 kV conductor had been replaced. Although the 12 kV conductor did not fail and fall to the ground, CAL FIRE requested that PG&E cut and remove the section of the conductor that contacted the tree as part of CAL FIRE's evidence collection; CAL FIRE also cut down and retained the tree as evidence (see figures 2 and 3).

Figure 2 – Subject Tree Stump

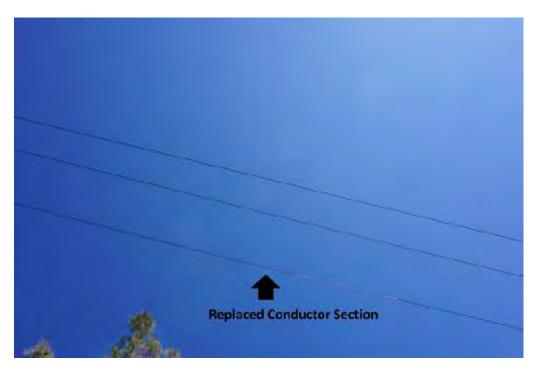
Figure 3 – Replaced Conductor Section

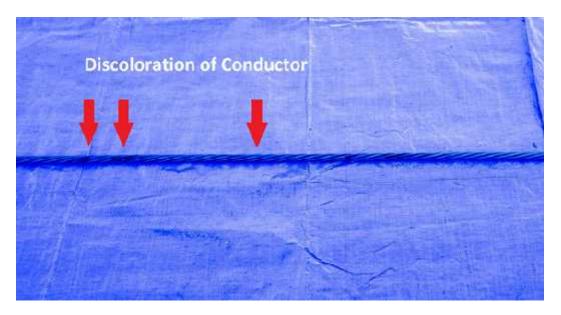
On September 22, 2015, SED staff examined the subject tree and conductor at CAL FIRE's Auburn Headquarters; SED staff observed that the subject tree was cut into sections and also noticed discoloration on the section of the conductor that had been removed (see figures 4 and 5).

Figure 4 – Discoloration on Conductor (Enhanced)

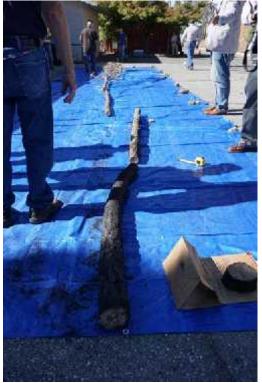
Figure 5 – Sections of the tree

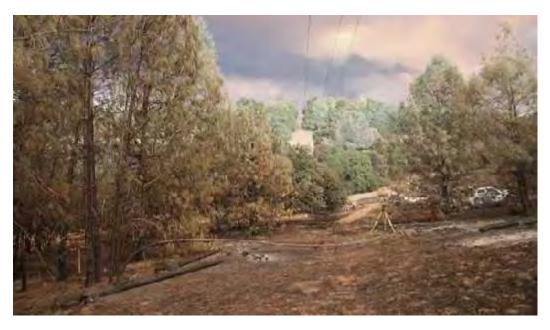
CAL FIRE's investigation report (see Attachment 1) determined that the subject Gray Pine tree leaned toward the ground, contacted the 12 kV conductor, and then continued to lean toward the

ground (see figures 6 and 7); when the tree contacted the conductor, the tree caught on fire, dropped burning embers onto dead fuels, and ignited the Butte Fire.<sup>3</sup>

Figure 6 -The pine tree lying on the ground after contacting the 12 kV conductor

CAL FIRE found that the removal of the two gray pines left the interior trees, including the subject tree, exposed to the south, towards the path of the sun and the powerlines. When a stand is altered and the interior trees are exposed to open spaces, the interior trees are prone to failure.

CAL FIRE's arborist (see Attachment 2) stated that trees that are captured within the confines of a dense stand do not develop reaction wood, have poor truck taper, and are inherently unstable. The additional exposure would cause secondary growth in the subject tree's canopy that would be most prolific on the southern side, facing the energized conductor. The new foliage and tip growth would cause the tree to fall to the south.

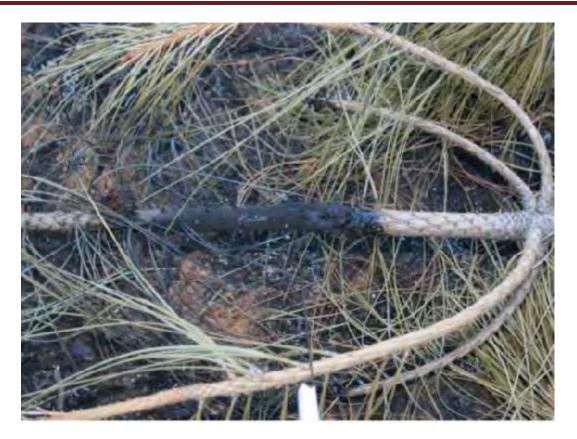
Figure 7 – Burn marks on the pine tree which indicates contact
