**Pacific Gas and
Electric Company**

RE: PG&E Supplemental Information Report & Materials

Carmel Gas Incident

Supplemental Report

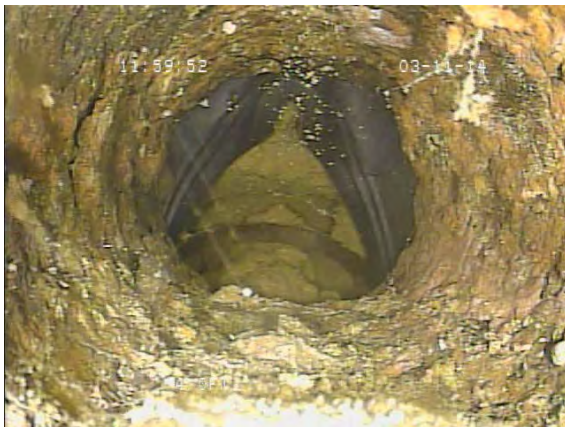
Figure 5. Collapsed main and offset joint

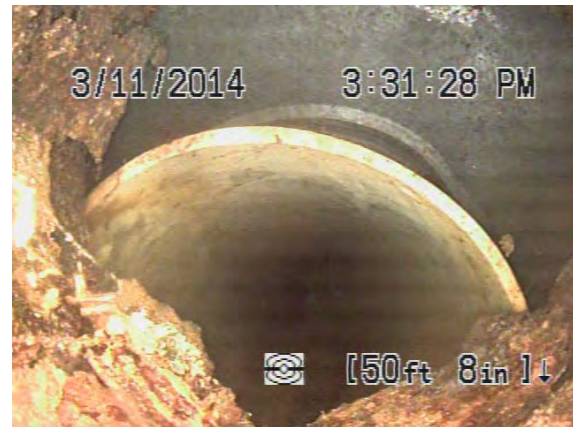
Figure 6. Offset joint 50 ft. from entry on property

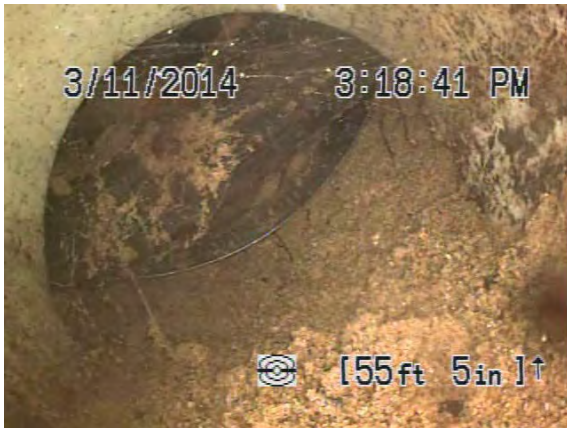
Figure 7. Lateral bend 55 ft. from entry

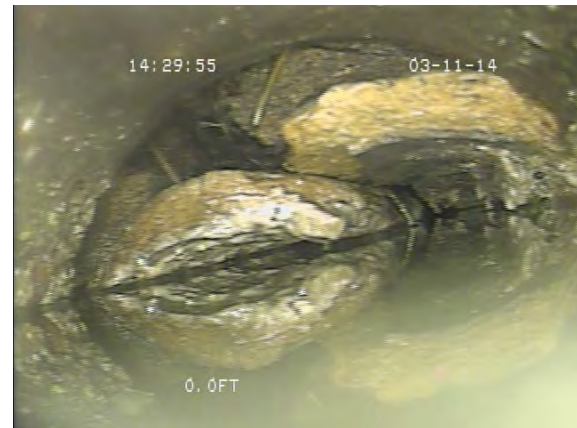
Figure 8. Collapsed main and water in sag

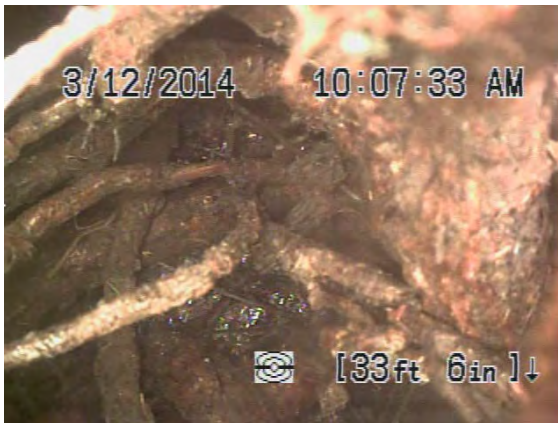
Figure 9. Lateral blocked by roots

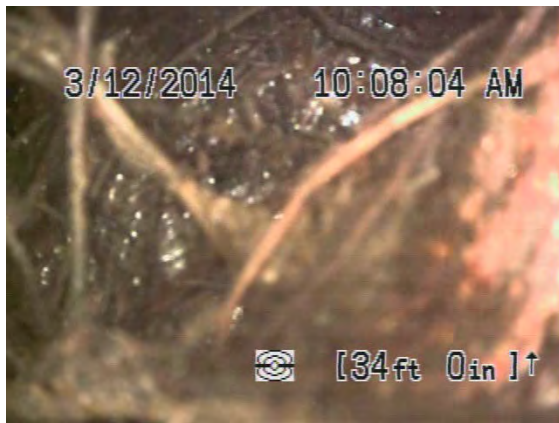
Figure 10. Roots over shiny apparent cap
