San Francisco Gas Event

Raymond Thierry
Pacific Gas and Electric Company
6121 Bollinger Canyon Road
San Ramon, CA 94583

Exponent, Inc.
149 Commonwealth Drive
Menlo Park, CA 94025

February 2018

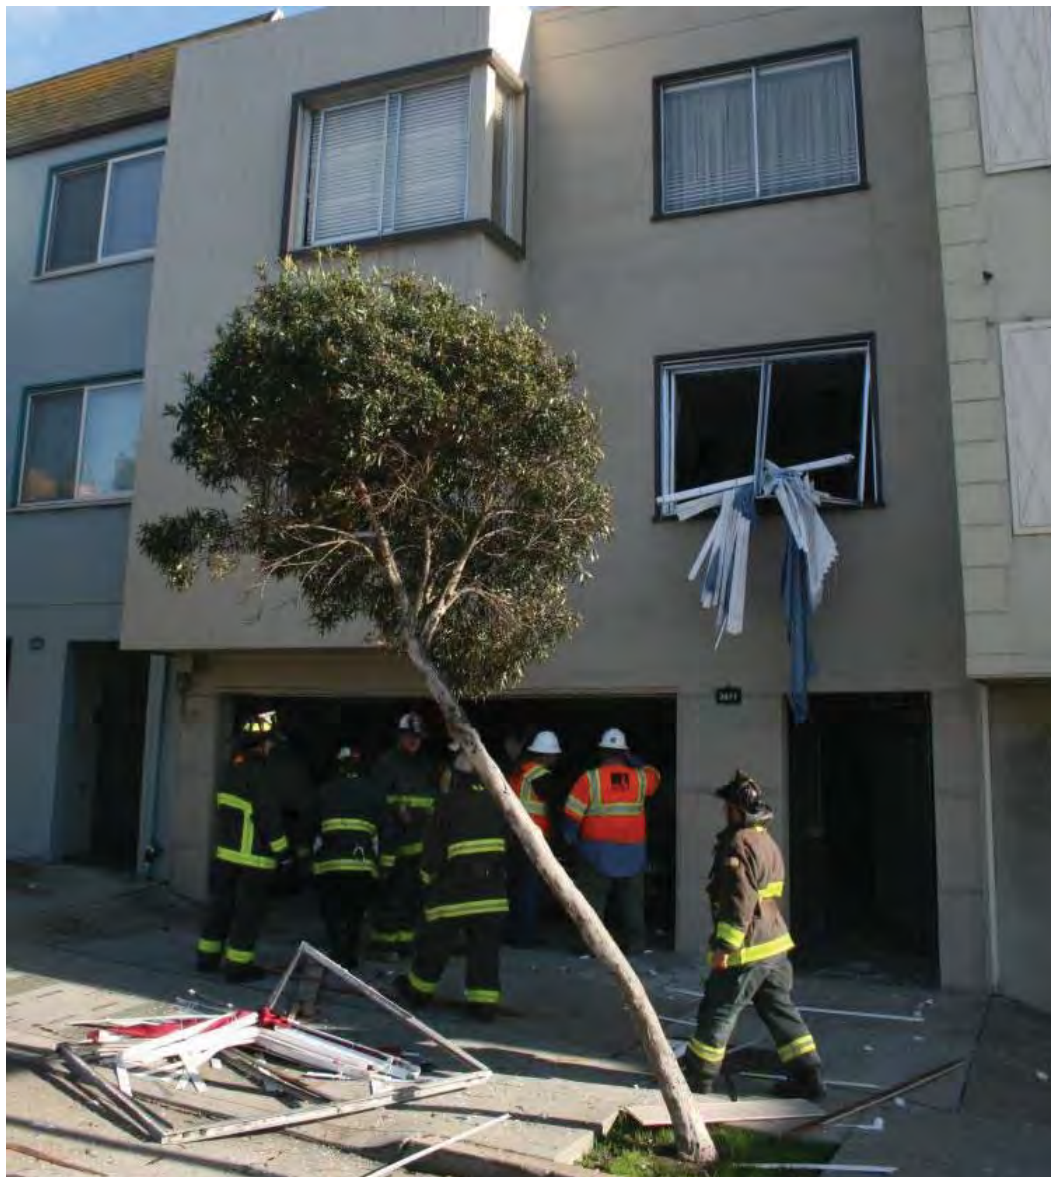
At the time of Exponent’s initial site examination on November 27, 2017, the third-floor windows at the front and rear of the building were observed to be undamaged. The second-floor rear windows were broken, and the second-floor front windows had been pushed out of the window frames and one was found lying on the sidewalk. Window glass from the second-floor front windows was strewn across Mission Street. On the ground level, the garage door had been blown out of the door frame and was found lying in the middle of Mission Street. Four automobiles were present in the garage. The ground-level rear windows were broken. Overall, the lower two levels of the incident house showed exterior damage that was consistent with an explosion occurring within the house. There were no outwardly visible signs of a fire occurring prior to or after the explosion. The front of the incident house is shown after the incident in Figure 3.

Figure 3. Front of [REDACTED], after the incident. Photograph taken by Exponent on November 27, 2017.

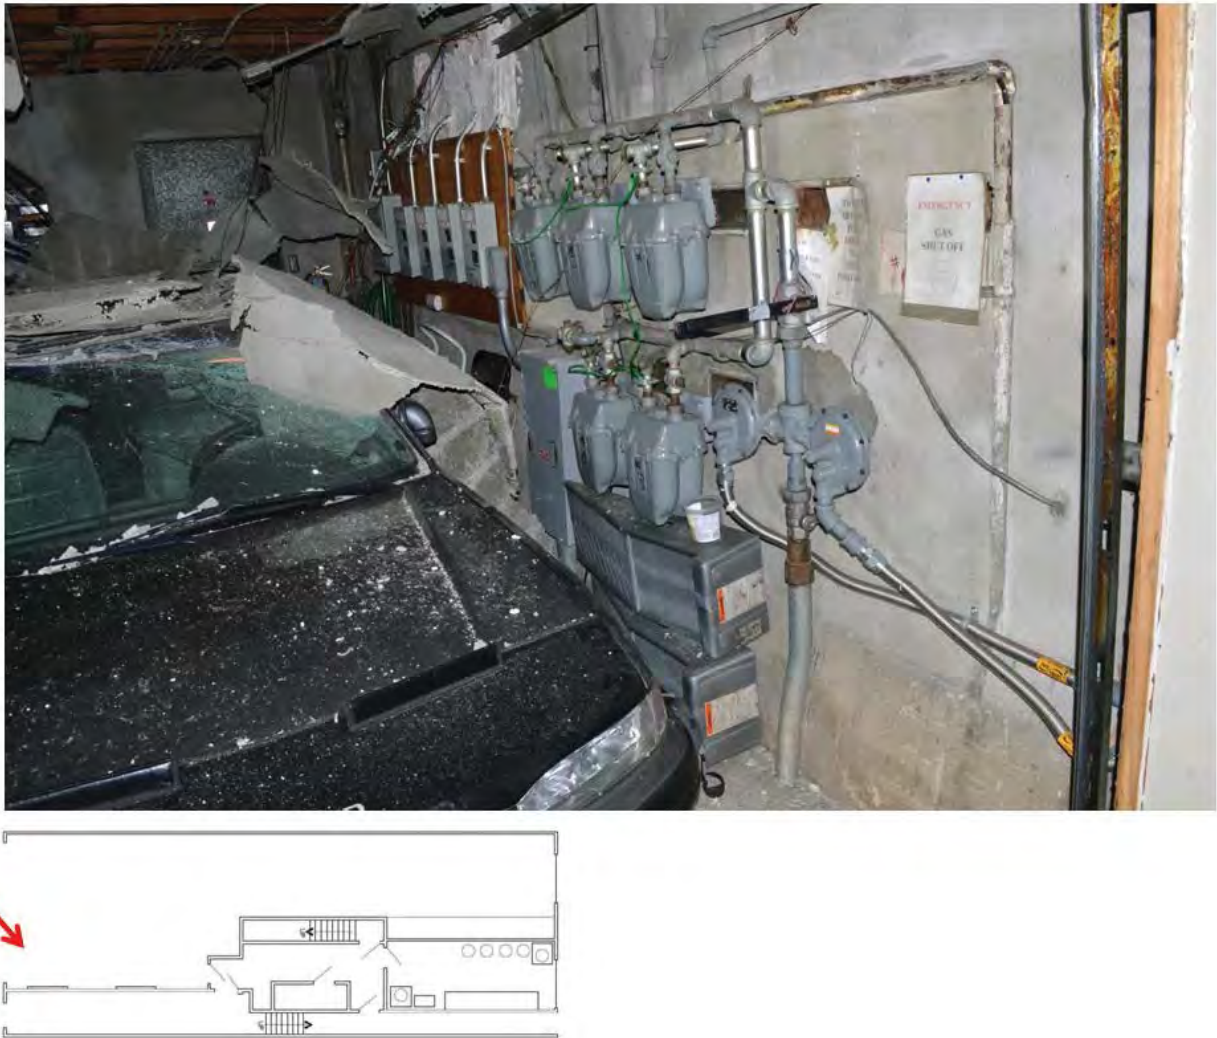
Figure 6. Gas meter set in garage at incident house. Photo taken by Exponent on November 27, 2017.

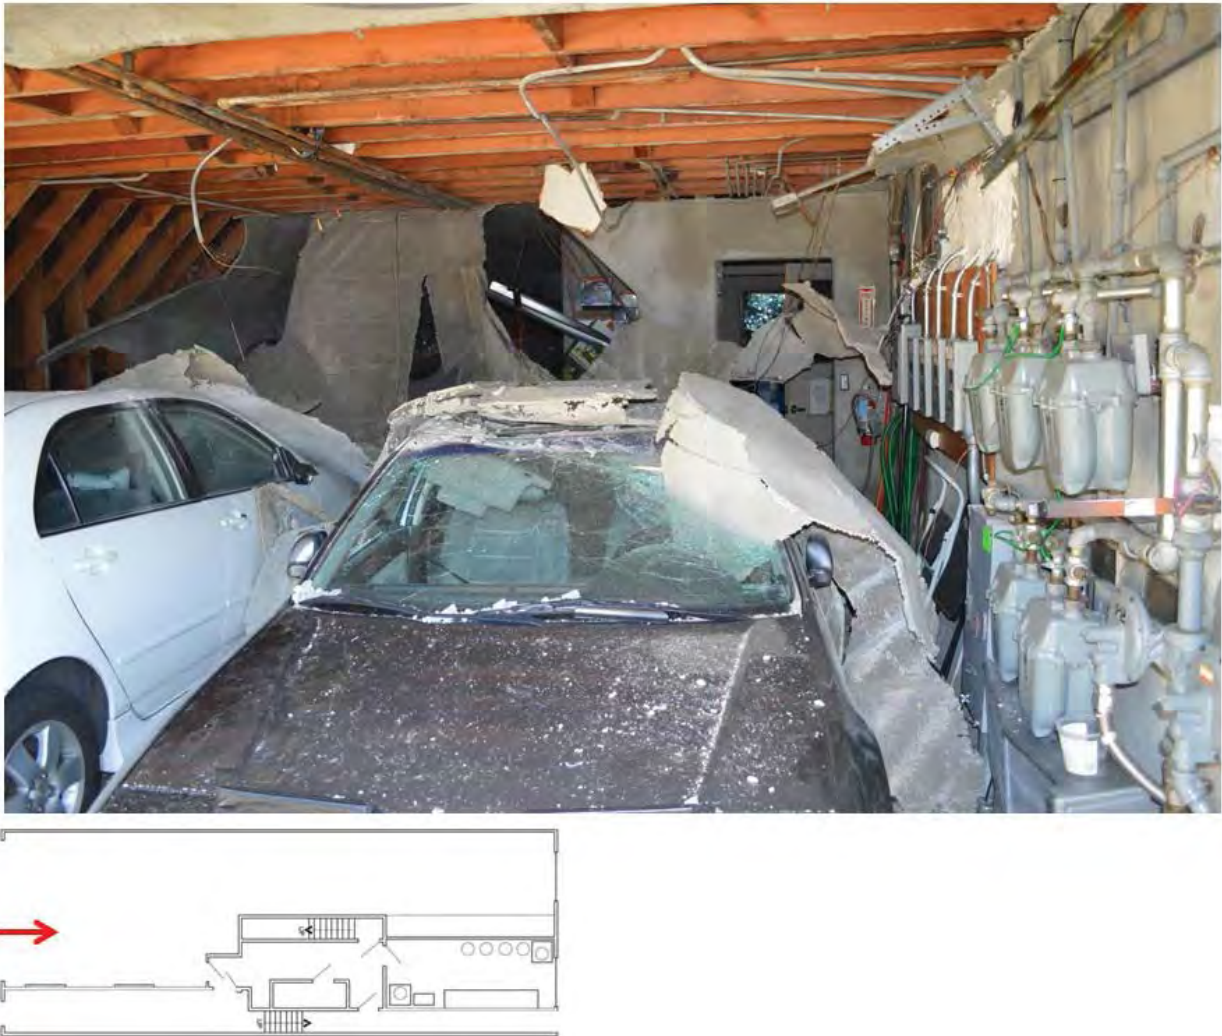
Figure 7. Front of garage at incident house. Photo taken by Exponent on November 27, 2017.

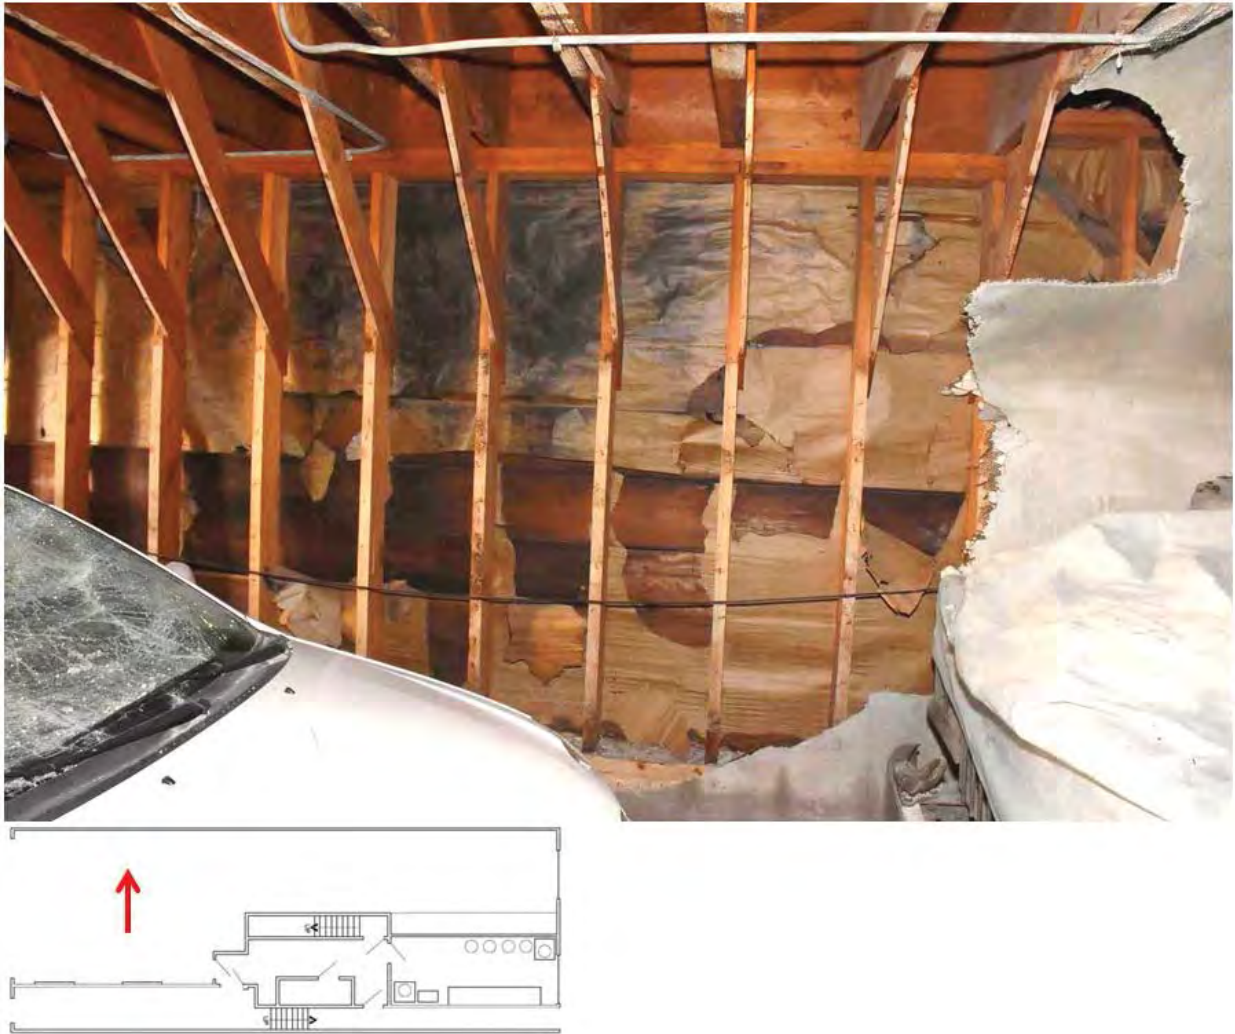
Figure 9. Thermal damage on north wall of garage at incident house. Photo taken by Exponent on December 1, 2017.

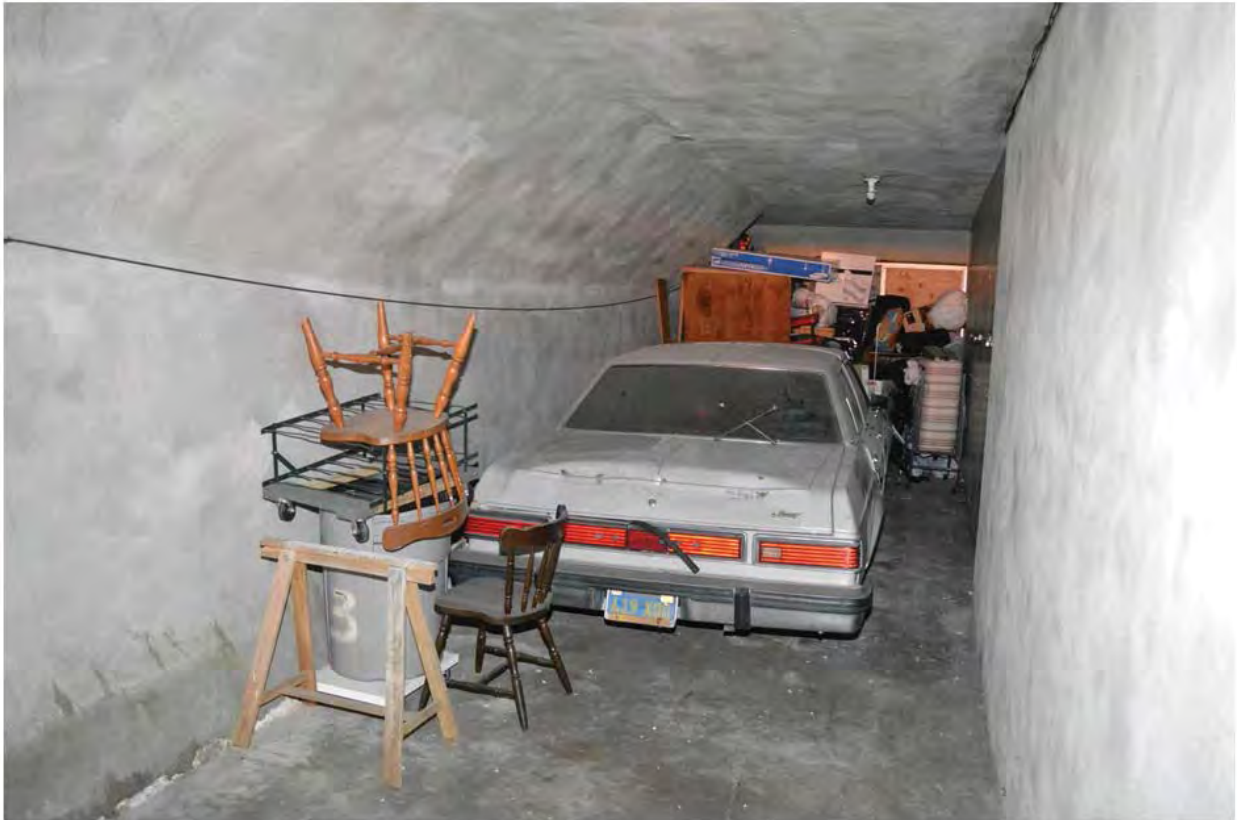
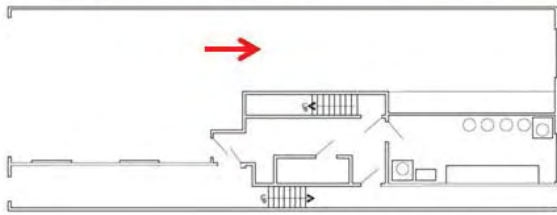
Figure 10. Rear (west end) of garage. Photo taken by Exponent on December 1, 2017.

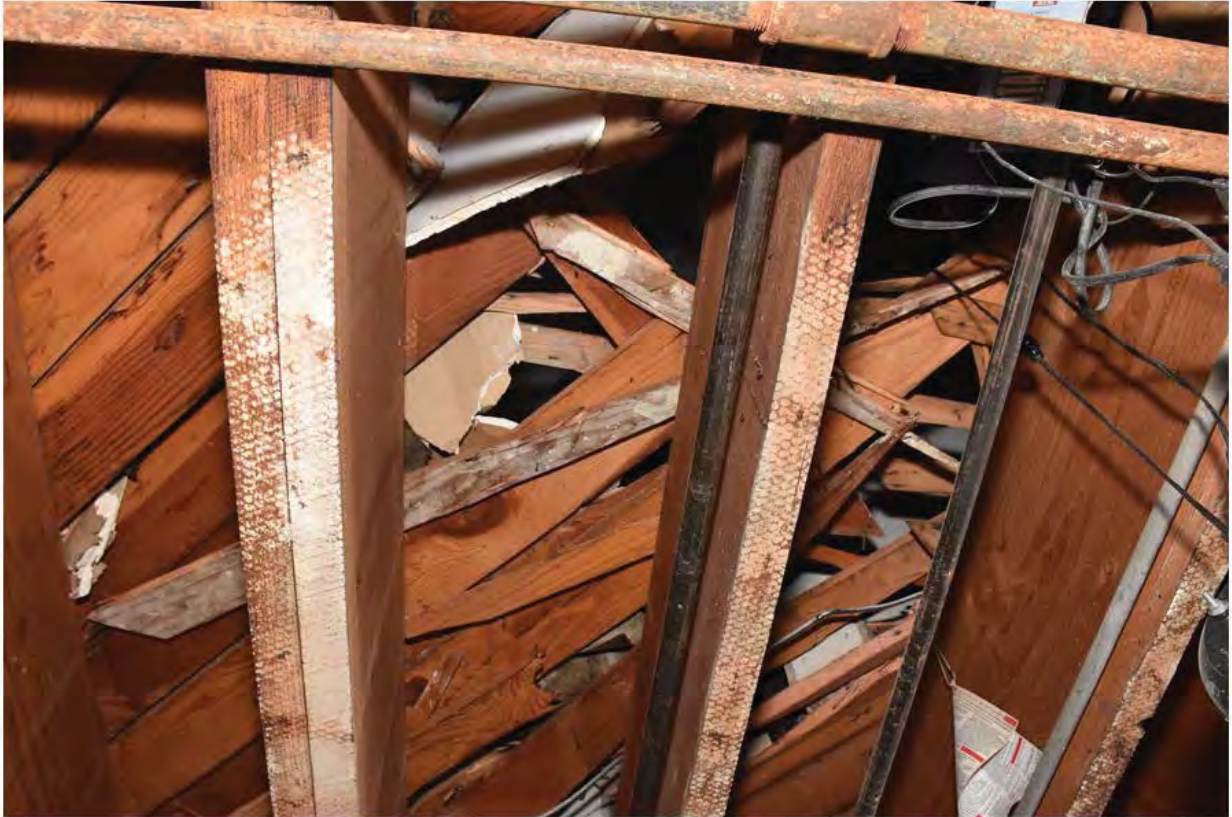
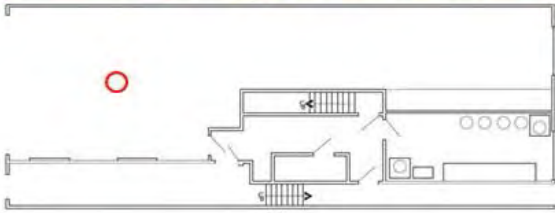
garage and were significantly damaged, as shown in Figure 11. The front entryway to the building was next to the garage. The entryway led to the main stairway to the upper level apartments. The walls and ceiling of the front entryway exhibited damage from the explosion, as shown in Figure 12. A laundry room was located in the rear of the building and contained five gas-fueled water heaters and a clothes washer and dryer. The exterior window in the laundry room was broken out.

Figure 11. View (facing up) of ceiling in garage with damaged floor boards visible in background. Photo taken by Exponent on December 1, 2017, at location indicated with a red circle.

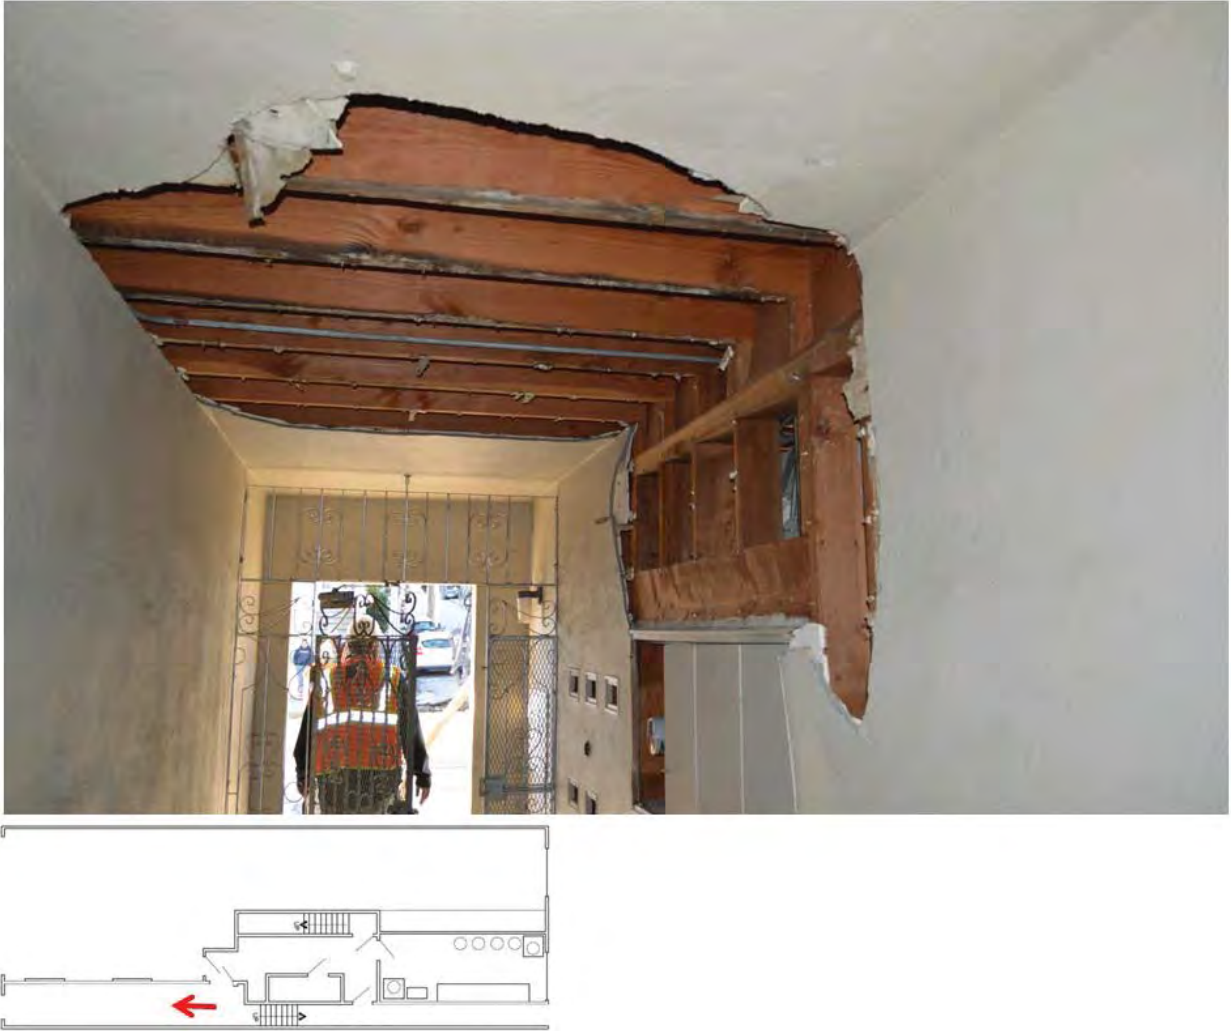
Figure 12. Damage to wall and ceiling in front entryway. Photo taken by Exponent on November 27, 2017.

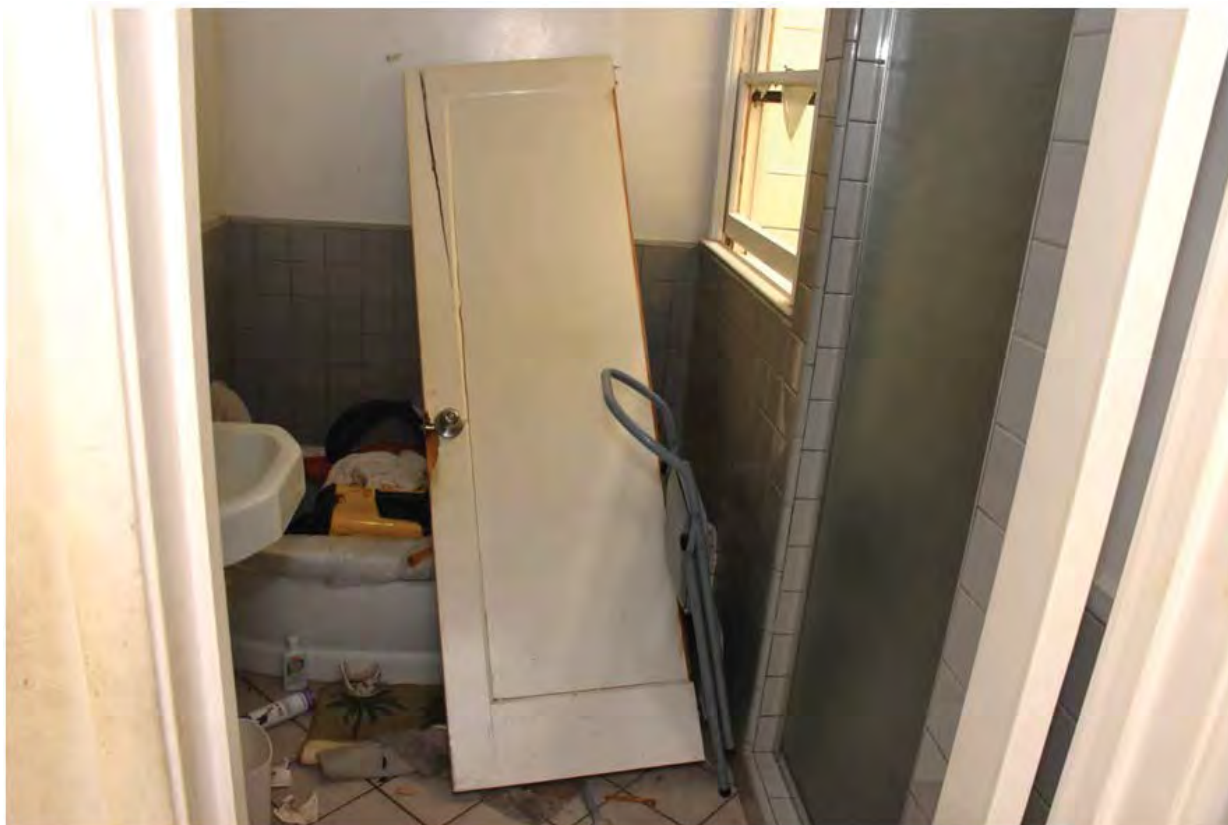
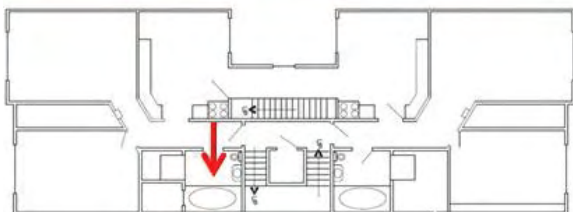
Apartment 1 showed significantly more damage than Apartment 2. The bathroom door in Apartment 1 was broken in, as shown in Figure 13. The bathroom exterior window was also broken as shown in Figure 13. The kitchen floorboards in Apartment 1 had been pushed up and were observed to be loose. The kitchen exterior window was also broken. The most severe damage in Apartment 1 was concentrated in the front of the apartment near the bedroom and living room. The floor in the bedroom had been severely damaged, and the floorboards were dislocated and scattered. The damage to the bedroom floor is shown in Figure 14. The living room in Apartment 1 showed very severe damage to the floor. The floorboards had been dislocated and scattered, and in some locations only the floor joists remained. The furniture in the living room had been displaced and upended. The living room is shown in Figure 15. The

Figure 13. Bathroom in Apartment 1. Photo taken by Exponent on December 1, 2017.

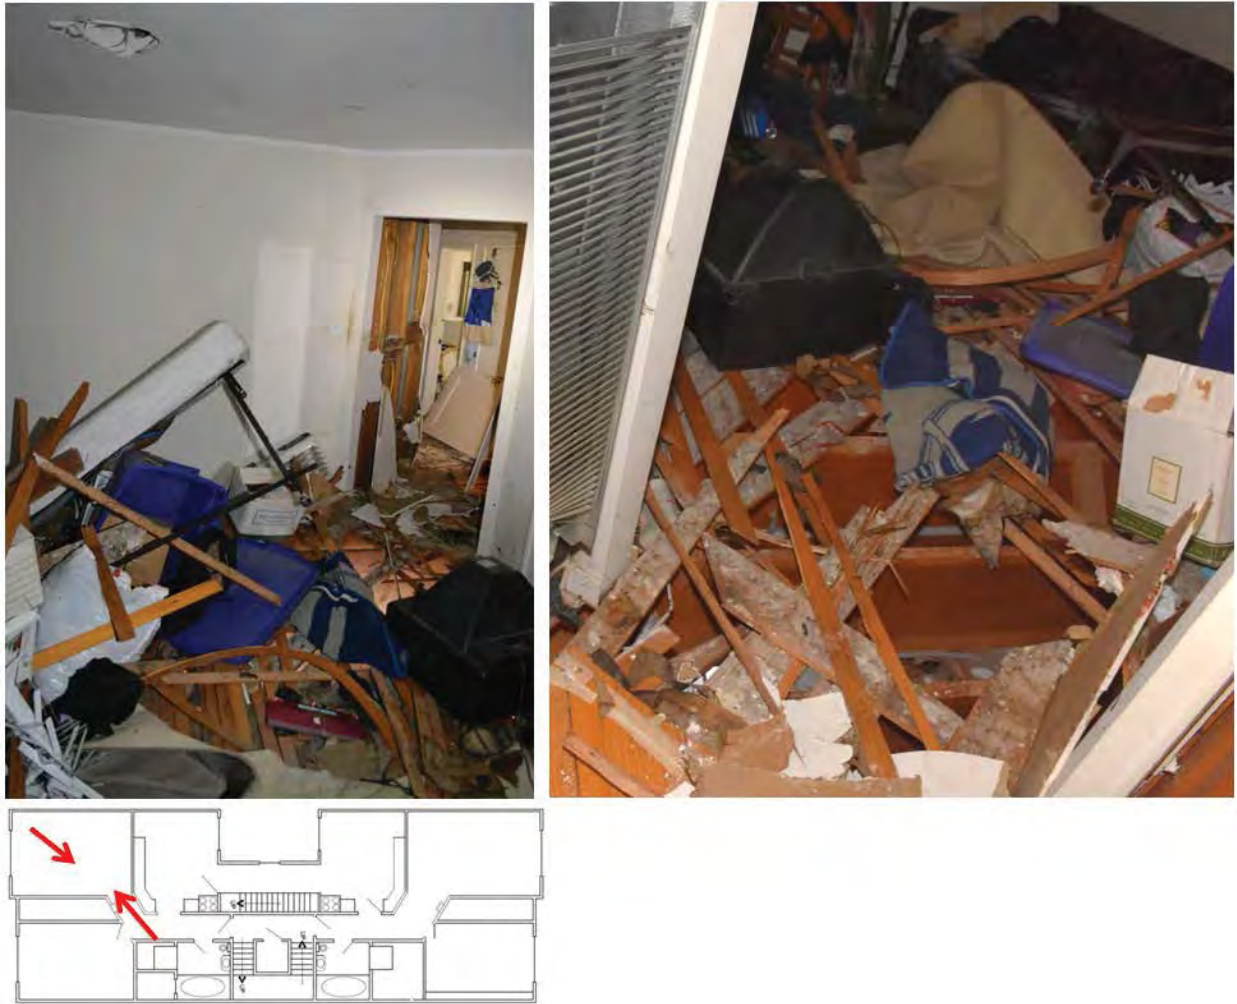
Figure 15. Living room in Apartment 1. Photo taken by Exponent on December 1, 2017.

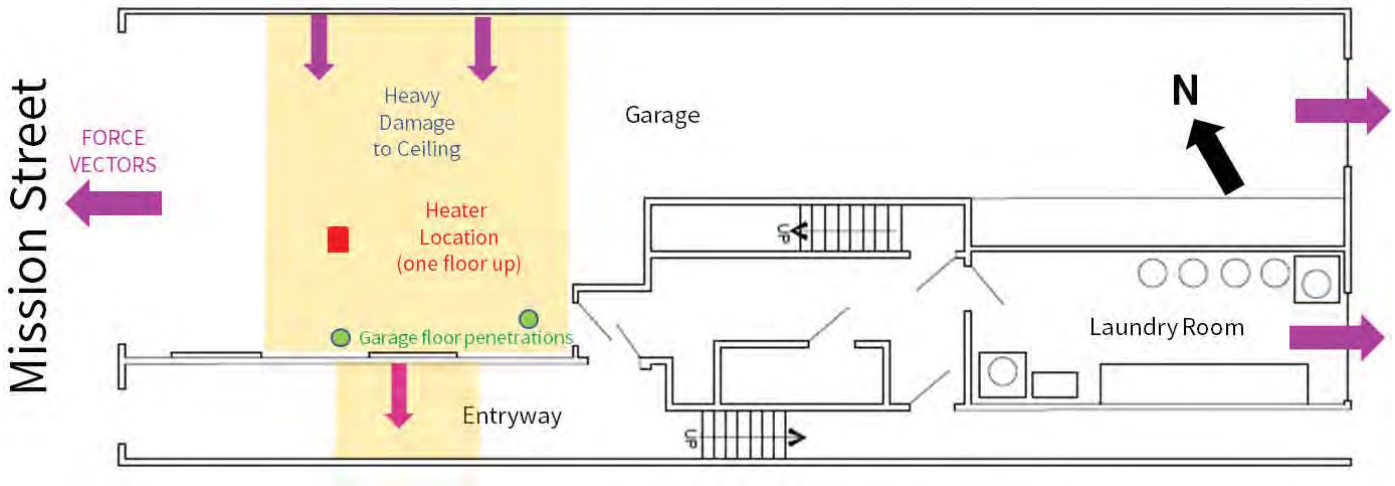
The damage vectors observed in the garage and on the second floor was overlaid on the building floor plans and is shown in Figure 16 and Figure 17. The floor and ceiling damage is shown in yellow, and damage vectors (such as broken windows, doors, and walls) are shown as purple arrows.

Figure 16. Damage vectors in garage of incident house.

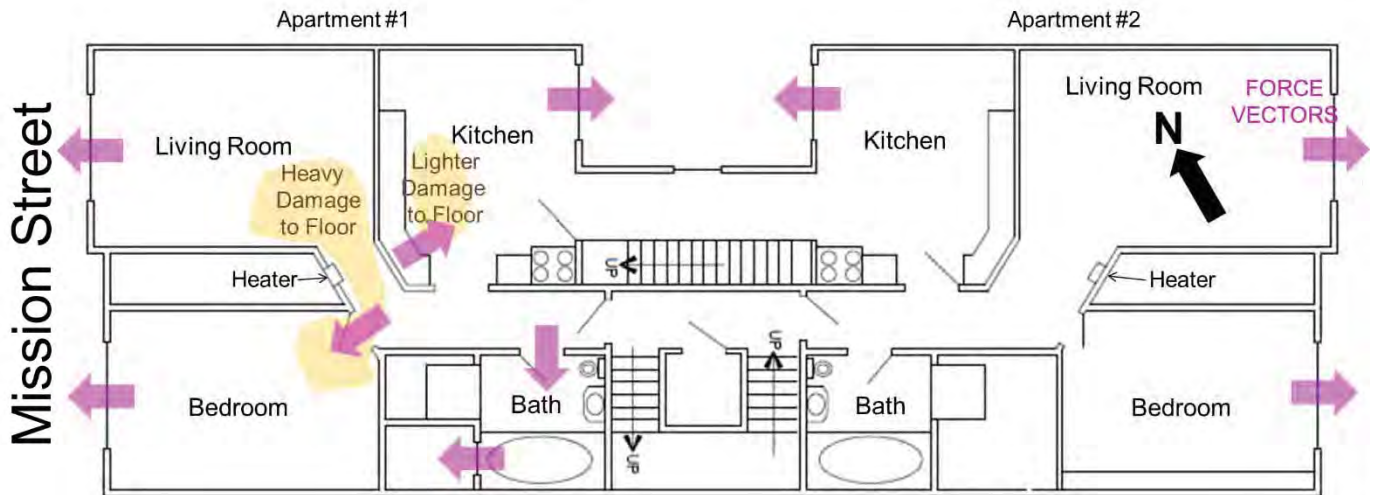
Figure 17. Damage vectors in second floor of incident house.

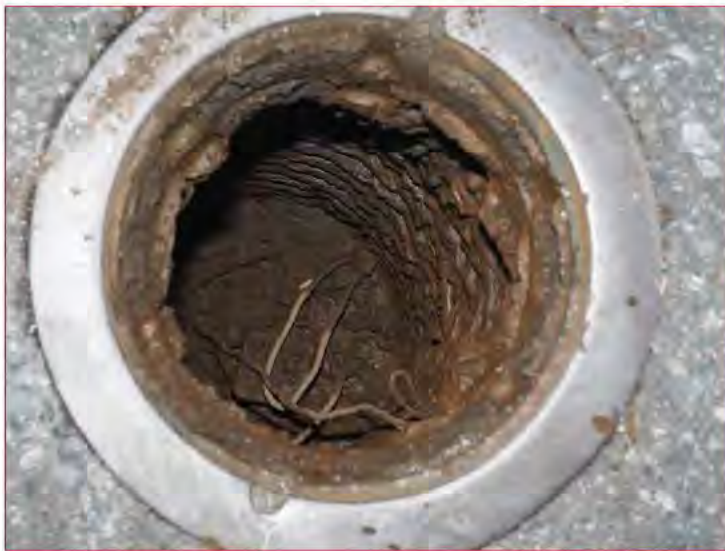
After the gas was shut in, an unmapped valve was identified on the cross-tie between the 6-inch steel main and the 6-inch plastic main. The valve was located near where the cross-tie connects to the steel main. The unmapped valve is shown in Figure 20.

Figure 20. Unmapped valve on cross-tie. Square valve operator faintly visible in the mud. Photos taken by Exponent on November 27, 2017.

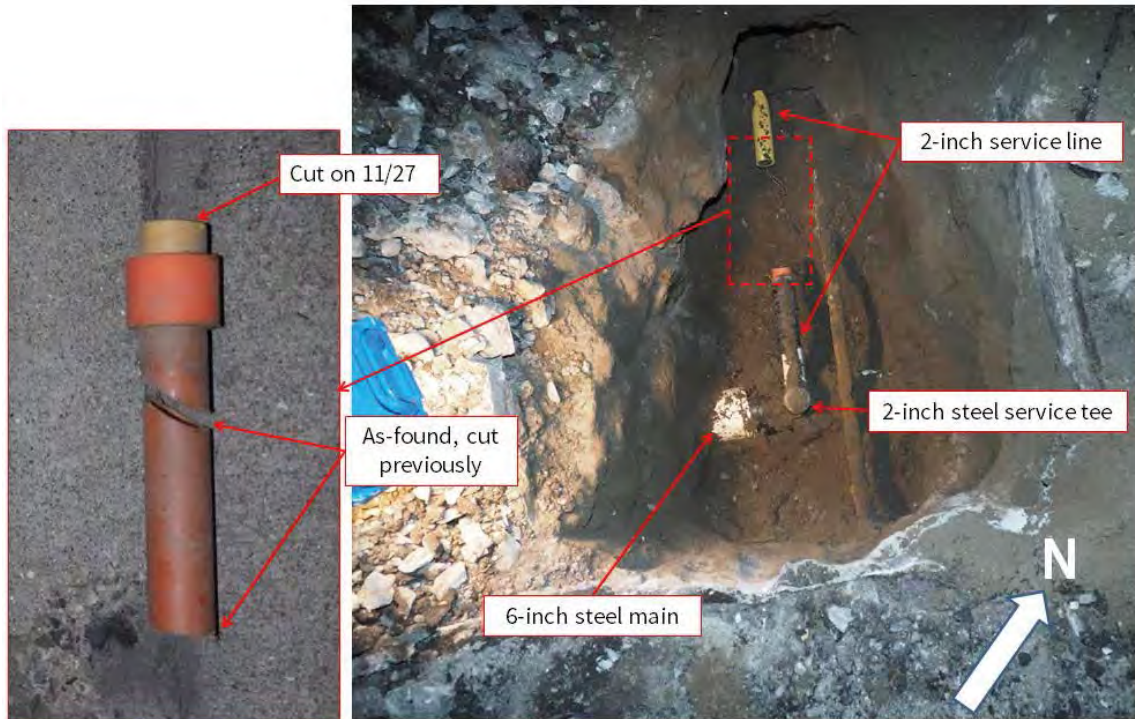
The steel main was excavated at the location labeled “Excavation #1” in Figure 21. When the main was uncovered, an abandoned service line was found extending northwest from the steel main. The service line consisted of a 2-inch steel Mueller service tee, a short section of 2-inch steel pipe, a plastic-to-steel transition fitting, a short section of 2-inch orange TR418 plastic pipe, a 2-inch fusion coupling, and a section of 2-inch yellow plastic pipe extending toward [REDACTED]. The abandoned service line is shown in Figure 22. When the service line was uncovered, there was a 6-inch-long section of orange TR418 plastic pipe that was cut previously, leaving an uncapped opening at the end of the stub. The cut section of pipe was found in the dirt adjacent to the cut pipe. The cut section of TR418 pipe is shown on the lefthand side of Figure 22, along with the fusion coupling that was cut out by PG&E on the day of the incident. The short piece of steel pipe, transition fitting, and orange TR418 plastic pipe were most likely a manufactured assembly. The plastic coupling was likely installed to connect the assembly to the yellow plastic service line. The yellow plastic pipe had a date code of “120591.” The service tee was removed, and Exponent retained the tee and two pieces of plastic pipe.

Figure 22. Abandoned service line uncovered at Excavation #1. Photos taken by Exponent on November 27, 2017.

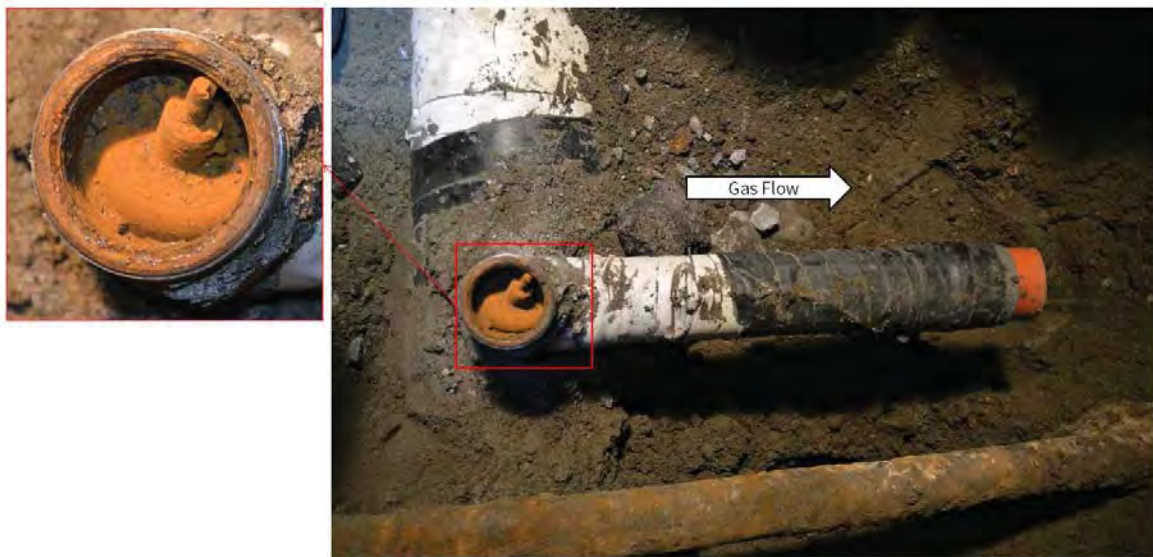
The completion cap was removed from the service tee and a rubber plug was found inside the tee. The uncapped stub and the rubber plug are shown in Figure 23 through Figure 26. A significant amount of rust was inside the upper portion of the service tee, as shown in Figure 25. The open end of the stub was found with a roughly cut outlet, as shown in Figure 26.

Figure 23. Rubber plug found inside service tee.

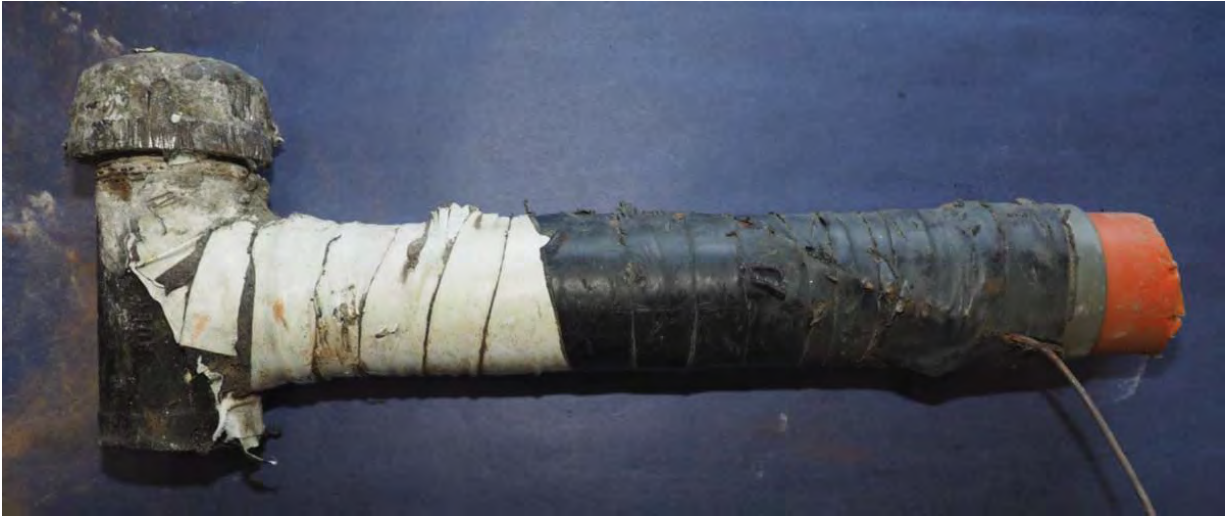
Figure 24. Service tee from at leak location.

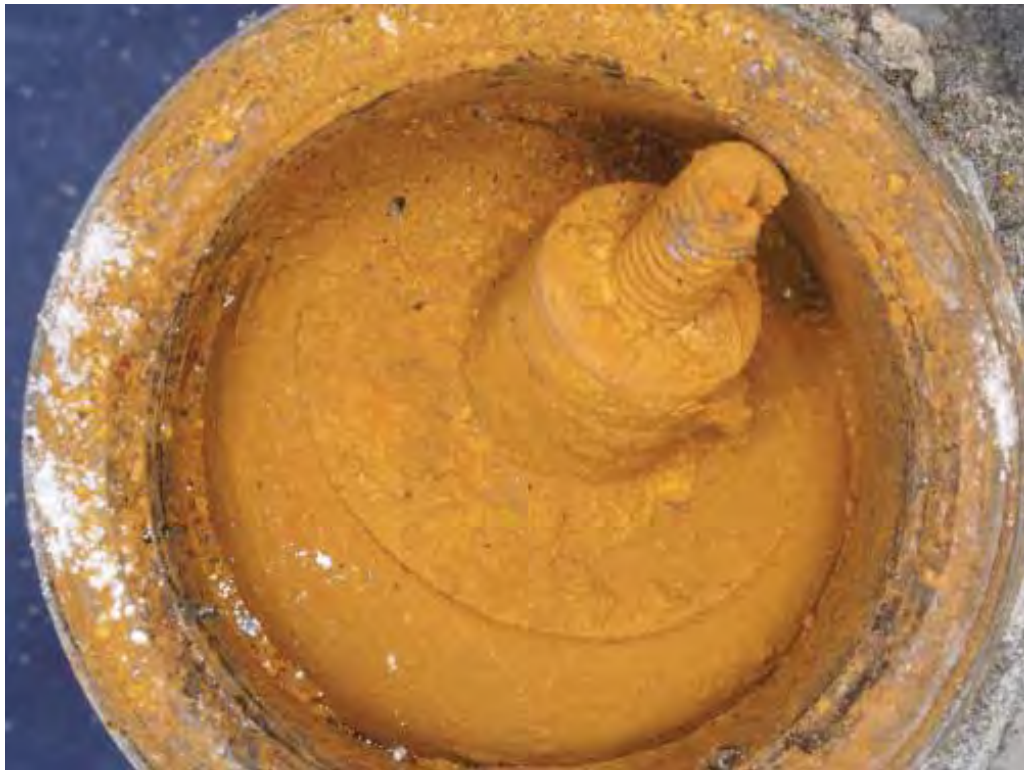
Figure 25. Rubber plug found inside service tee.

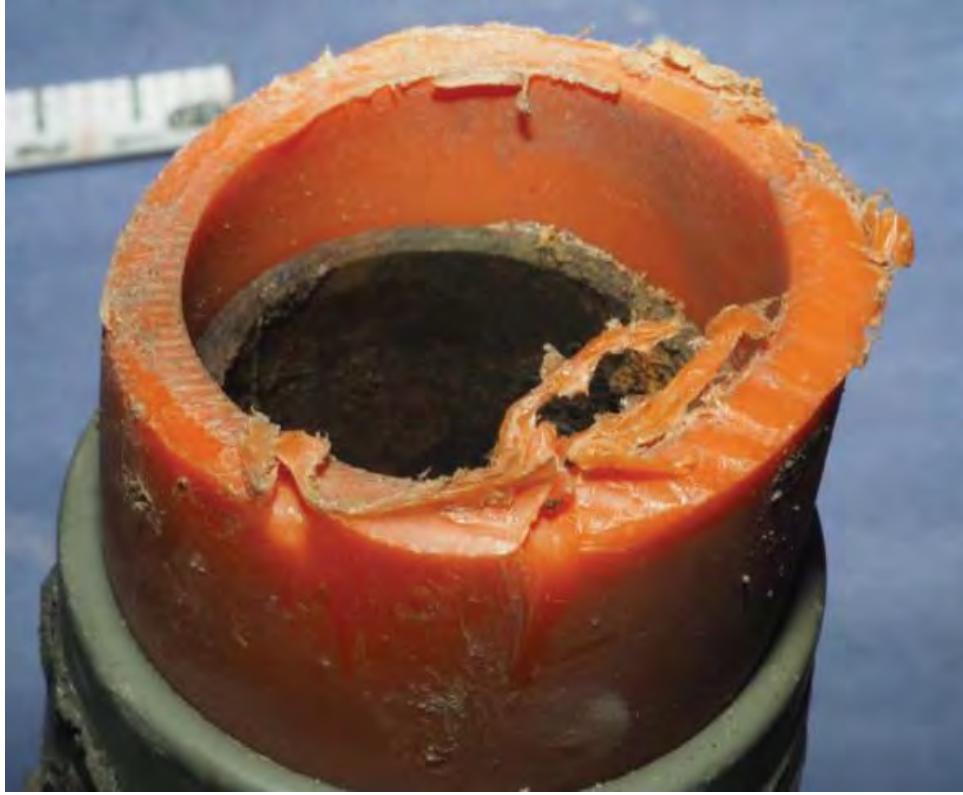
Figure 26. Cut end of stub as found.

of plastic pipe remaining on the end of the stub. This is not enough plastic pipe to attach a mechanical end cap or a fusion end cap. GS A-93.2 permits the stub to be sealed with a cap welded on the steel pipe, as shown in Figure 30. A steel cap was not attached to the end of the incident stub.

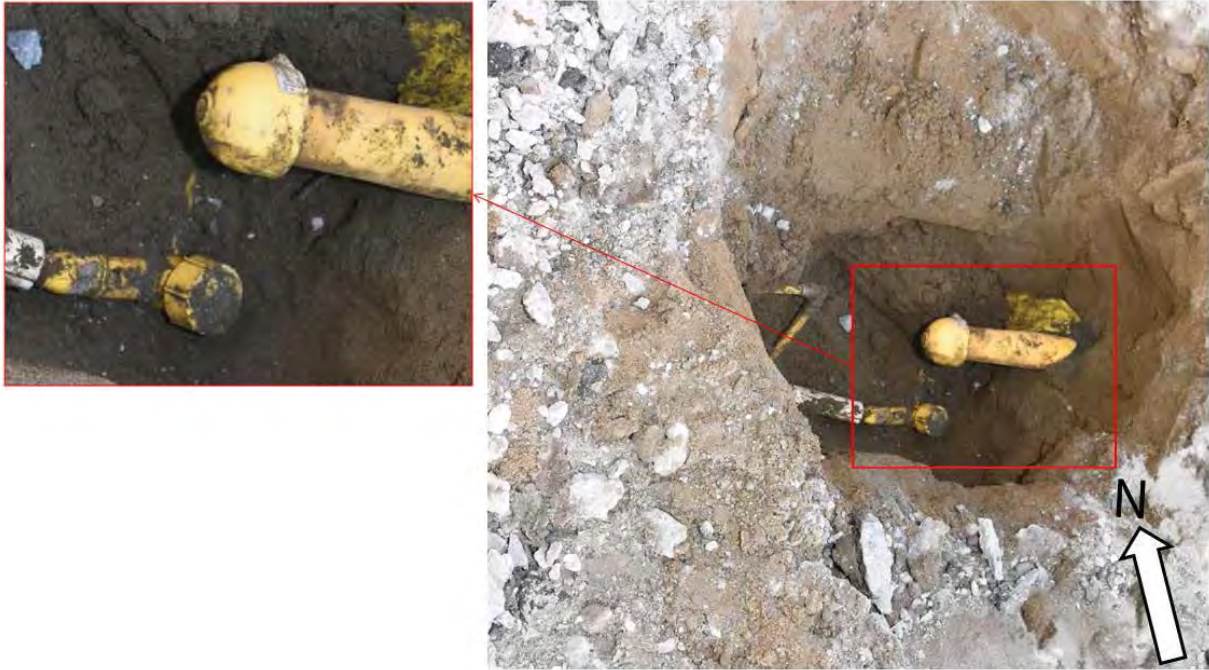
On December 19, 2017, excavations were performed at locations 1 and 2 (shown in Figure 21). The excavation at location 1 was performed first, and cameras were inserted into the abandoned 2-inch service line. Based on the camera examination, it was determined that there was some type of plug or cap on the end of the 2-inch service line at the approximate location where it crossed the 6-inch plastic main. An excavation was performed at location 2 (shown in Figure 21), and it was discovered that the west end of the of the plastic service was sealed with an Uponor socket fusion cap, as shown in Figure 27. A prior squeeze point was identified adjacent to the socket fusion cap, based on the pipe being oval shaped at that location. A Constab cap fitting was installed on the east side of the abandoned service line, and the line was pressure tested with air at 60 psig for 5 minutes and no leakage was observed.

Figure 27. End cap on west end of abandoned 2-inch plastic service line.
