SIF Potential -Deer Park Incident

Root Cause  
Evaluation Report

Deer Park, CA

SAPN # 7034203

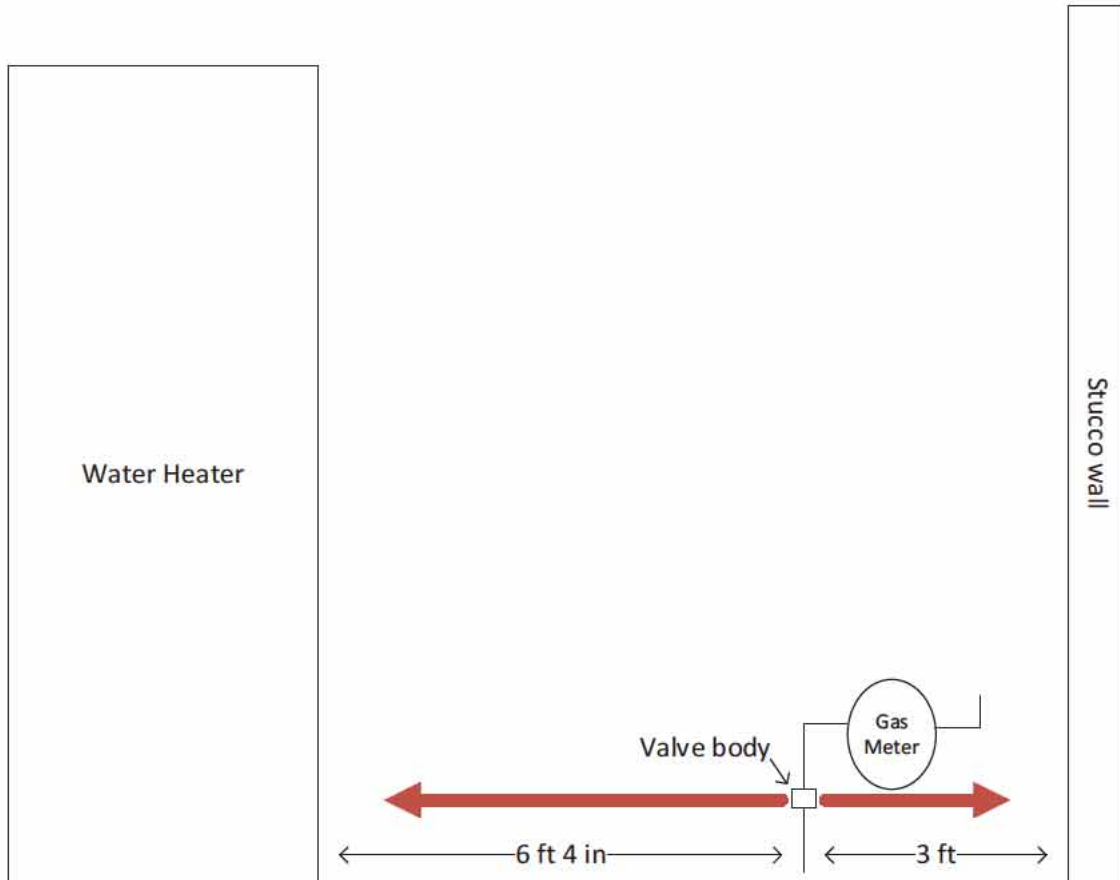
**Figure 5: Assumed gas flow path of release**

frozen, the Gas Mechanic stated that he loosened the packing nut and then tapped the core with a hammer. In a second the packing nut backed off the valve and the core shot out of the valve body. Approximately 56 psig gas was released uncontrollably out of the valve body, which directly aligned with a water heater located 6' 4" away. Gas flow direction, depicted in Figure 5, would have been directed towards the water heater and the stucco wall.

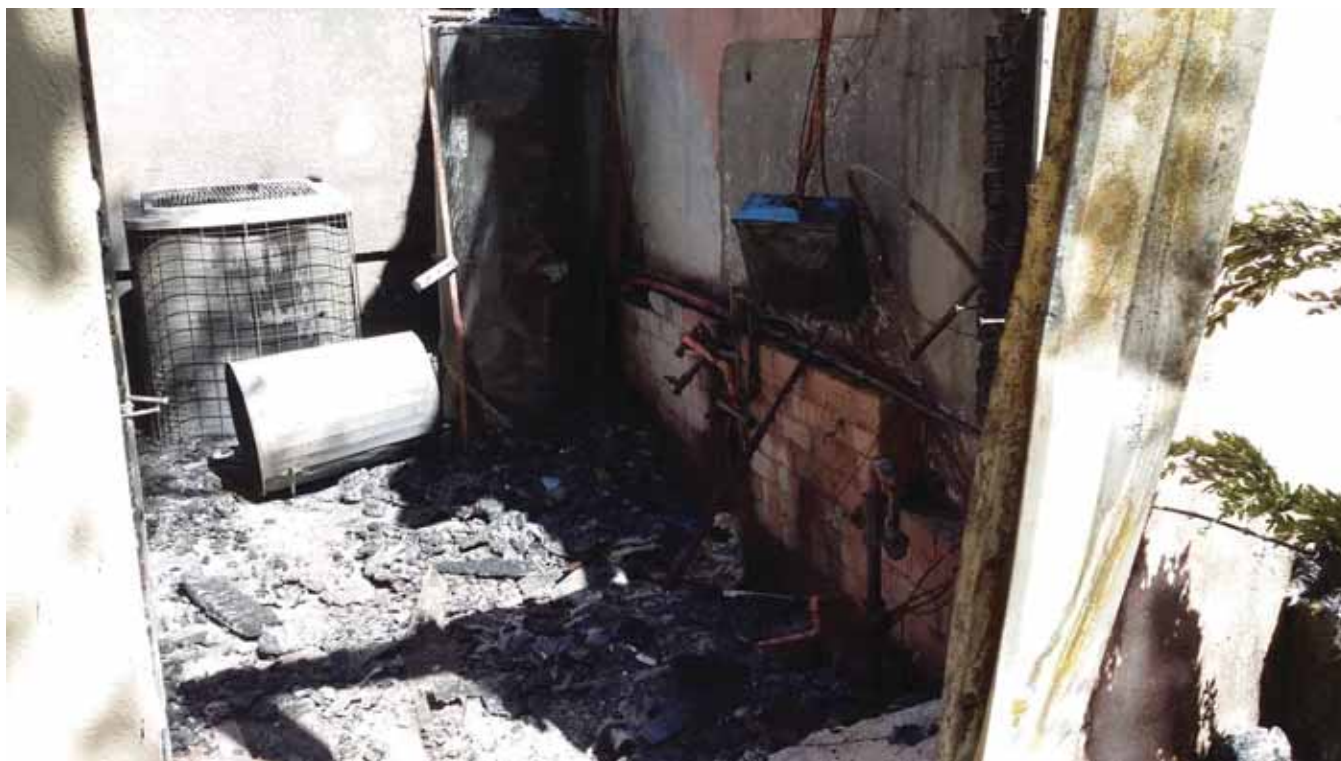
**Figure 6: Damage to customer house**

Almost instantly, the gas ignited, resulting in a fire. It cannot be confirmed what the source of ignition was, however there were multiple potential sources present in the semi-enclosed space, the water heater with a standing pilot, air conditioner, and customer's electrical panels. The Gas Mechanic used the fire extinguisher located on the jobsite, while the Fitter Arc called 9-1-1 as he ran back to the trucks for additional fire extinguishers. Unable to extinguish the fire and concerned for their safety, the crew relocated to a safe location. The Fitter Arc received minor 1st degree burns and the Gas Mechanic received 1st and 2nd degree burns on his arms. The fire department arrived on-site and controlled the fire from spreading. A secondary gas crew arrived to excavate and squeeze the service and stop the flow of gas, the fire department extinguished the fire, and the gas crew disconnected the gas service at the main. Photo of the meter set location after the fire is found in Figure 6. The service line feeding this customer was not equipped with an excess flow valve (EFV) because it was installed at a time when EFVs were not required (the gas service was installed 1949 and the service had not been reconstructed since then). Had an EFV been installed, it likely would have activated and stopped the release of gas.

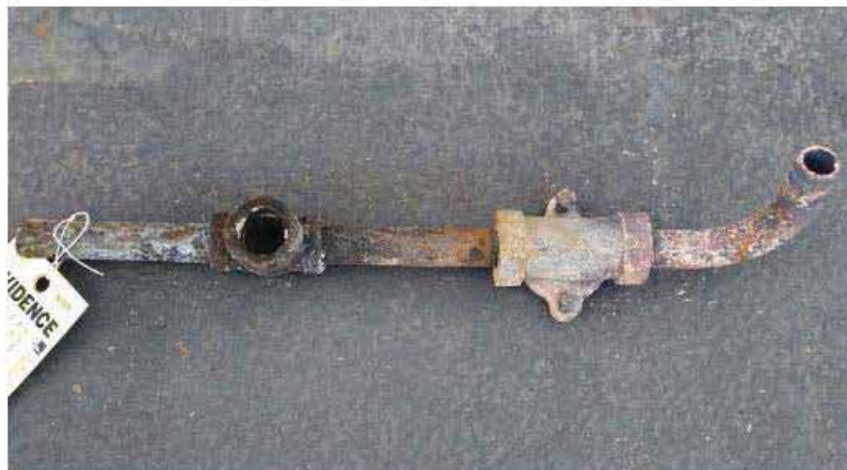
The Nordstrom service valve was found with all its components (*spring, valve plug and square plug*) disassembled at the time of the inspection (*September 2, 2016 at 2:05 P.M.*) There was no evidence of exposed metal or corrosion removal on the tang surface indicating the use of tools for its operation. The as-found condition and appearance of the service valve components do not represent the condition of the components during service. The components were exposed to fire, water, and environmental elements which accelerated the corrosion and appearance.

Figure 1. As found service valve body and piping.

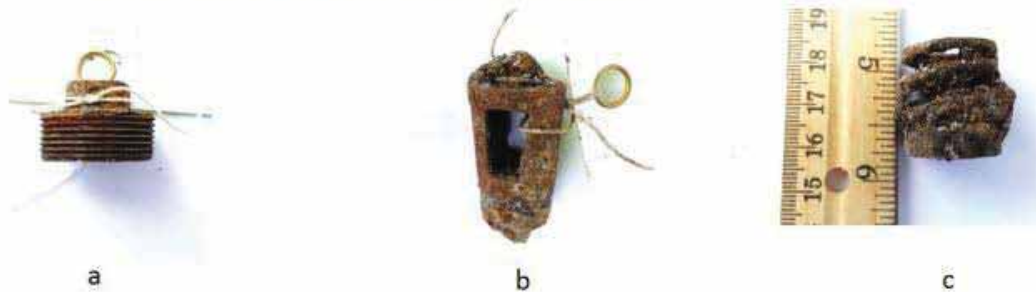
Figure 2. As found service valve components: (a) square plug, (b) valve plug, (c) spring.

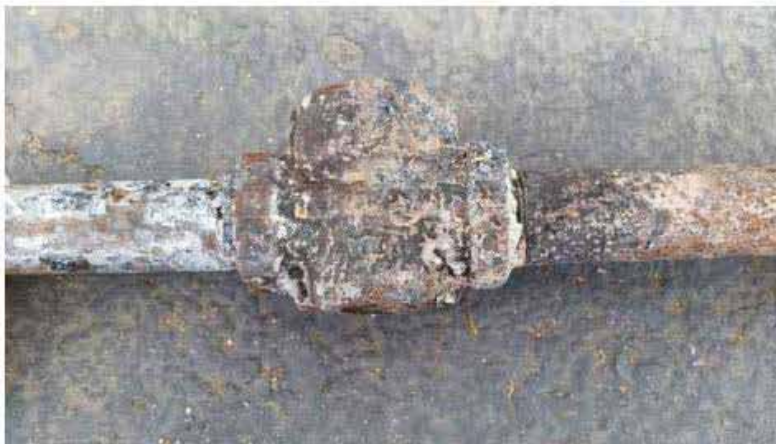
The exterior area around the shutoff valve and piping was found to be scorched and blackened. There were no indications of exterior valve body damage.

Figure 3. As found service valve body (exterior).

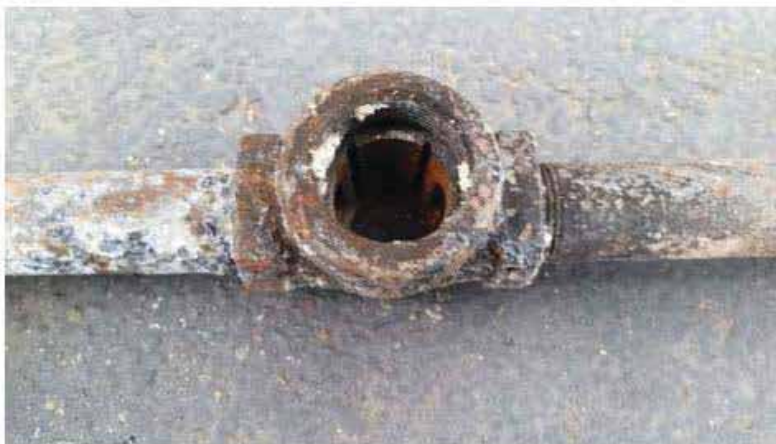
Figure 4. As found service valve body cavity.

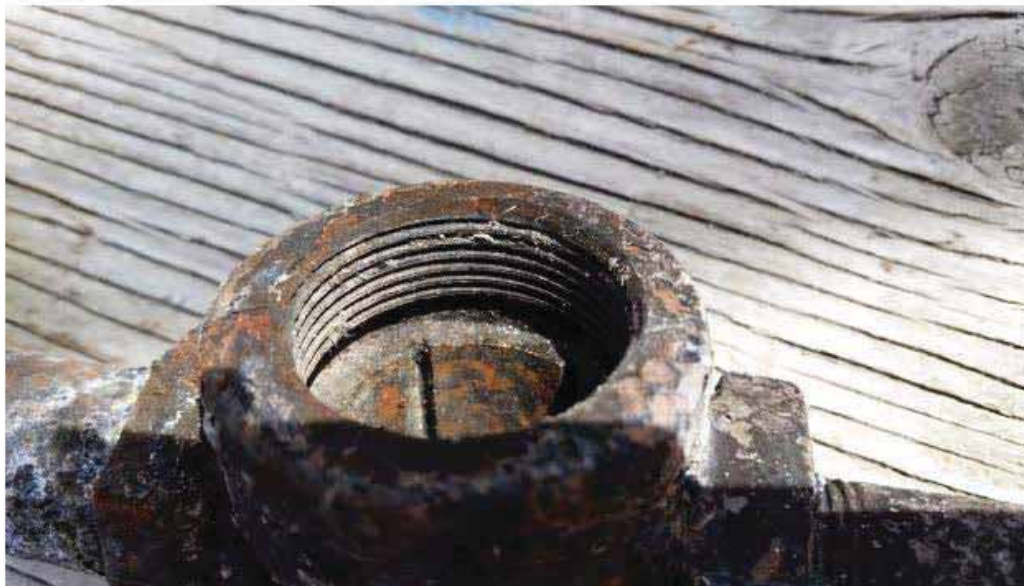
The interior of the valve body was found to be scorched and blackened. There were no indications of interior valve body damage.

The body cavity threads had no visible damages (cross-threading or damages on thread crests). Also, the threads had proper thread continuity. Overall, the threads were found in good mechanical condition. Moderate corrosion was found on the internal valve cavity, but no indication of corrosion on the threads. No evidence of grease or pipe sealant was found on the surface of the threads.

Figure 5. As found service valve body cavity.

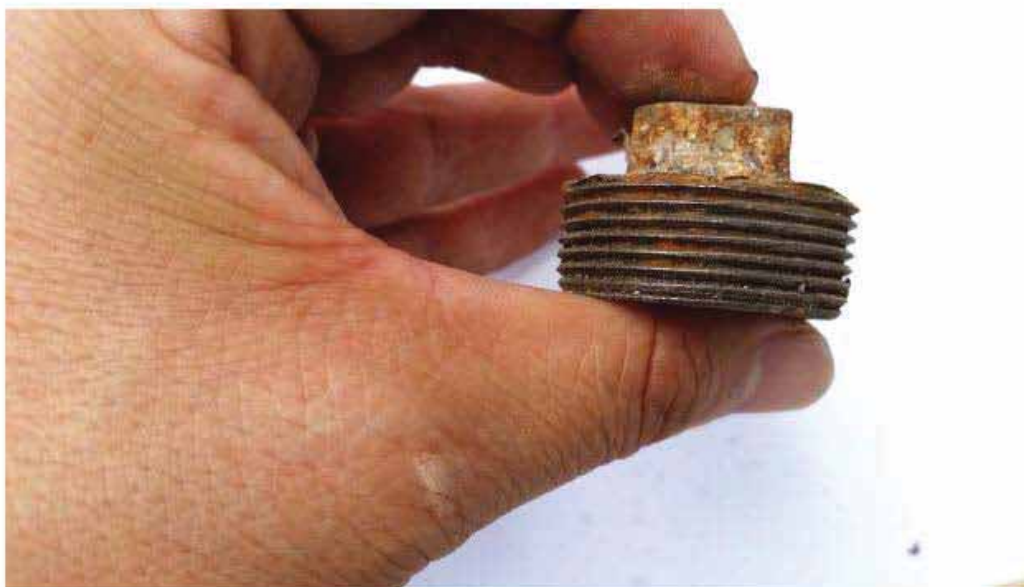
The threads on the square plug had no visible damages (cross-threading or damages on thread crests). Also, the threads had proper thread continuity. Overall, the threads were found in good mechanical condition.

Moderate-to-severe corrosion was found on the external and internal body of the plug as well as throughout the entire threads. No evidence of grease or pipe sealant was found on the surface of the threads.

Figure 6. As found square head plug.

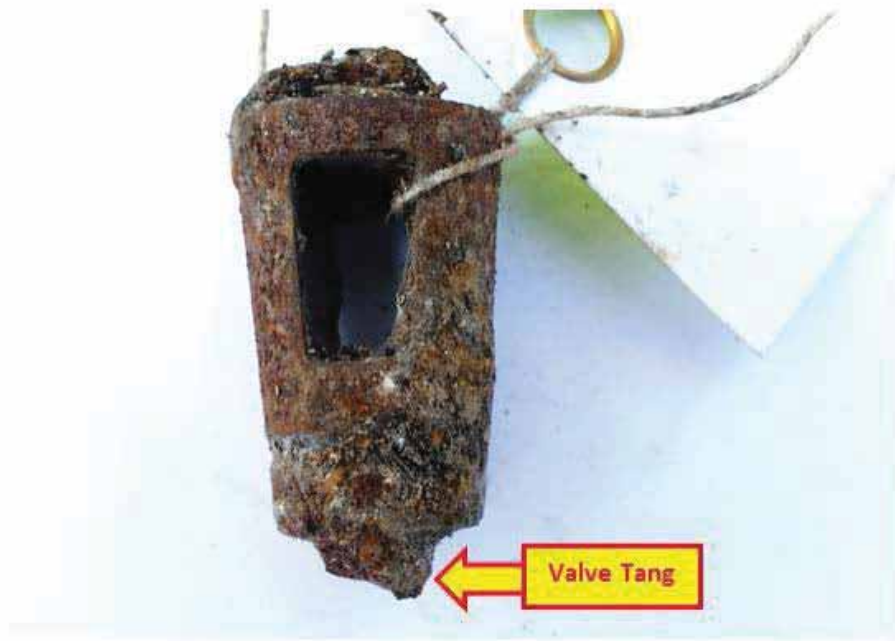
No evidence of exposed metal or corrosion removal on the tang surface indicating the use of tools for its operation. The valve plug was found to have severe corrosion on its entire surface. The valve tang was almost completely absent and the section that was left was corroded. No evidence of grease was found on the surface of the plug.

Figure 7. As found valve plug.

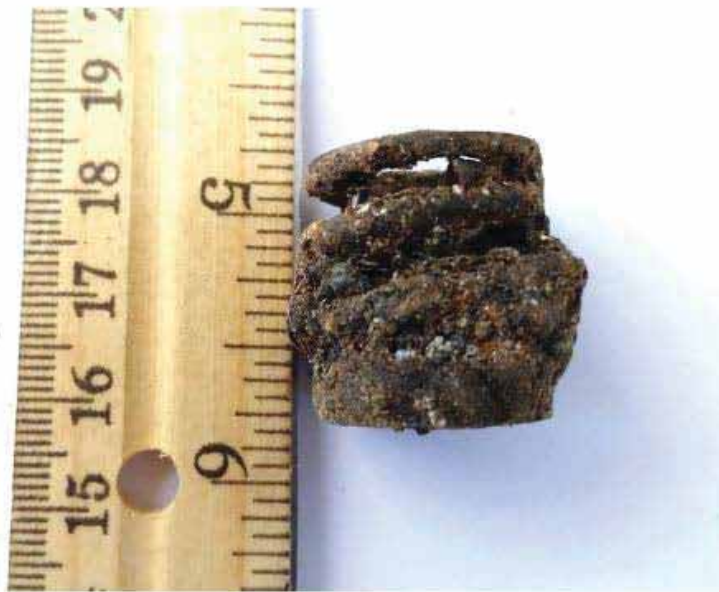
The spring was found to be covered in dry grease and debris imbedded in the coils. Nevertheless, no mechanical damage was found.

Figure 8. As found spring.

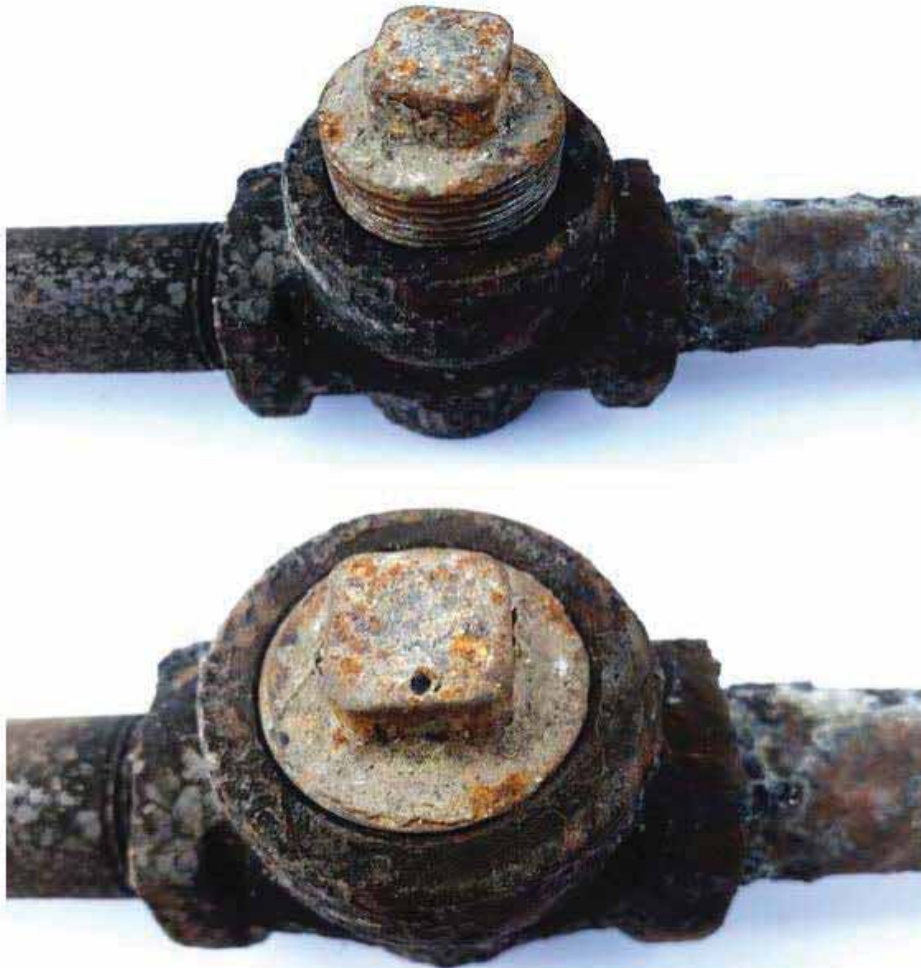
The spring, valve plug and square plug were installed as an assembly in order to check for proper component fit. It was found that all components fit properly to make the assembly.

Figure 9. Service valve assembly

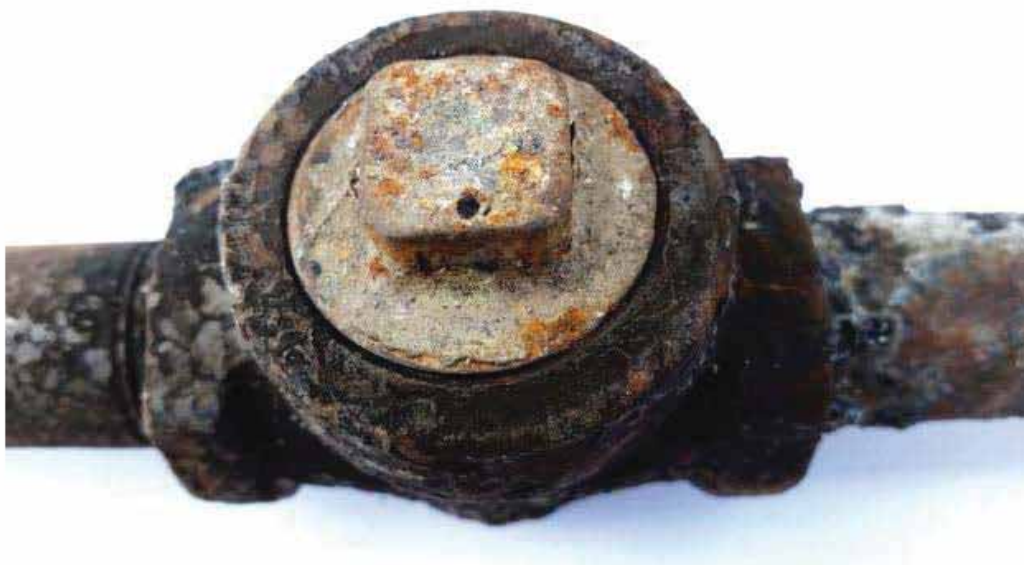
With the spring in place it was found it takes four complete turns to make the bottom surface of the square plug level to the top surface of the valve body.

Figure 10. Square head plug level to the top surface of the valve body.
