**CALIFORNIA PUBLIC UTILITIES COMMISSION
Safety and Enforcement Division
Electric Safety and Reliability Branch**

Incident Investigation Report

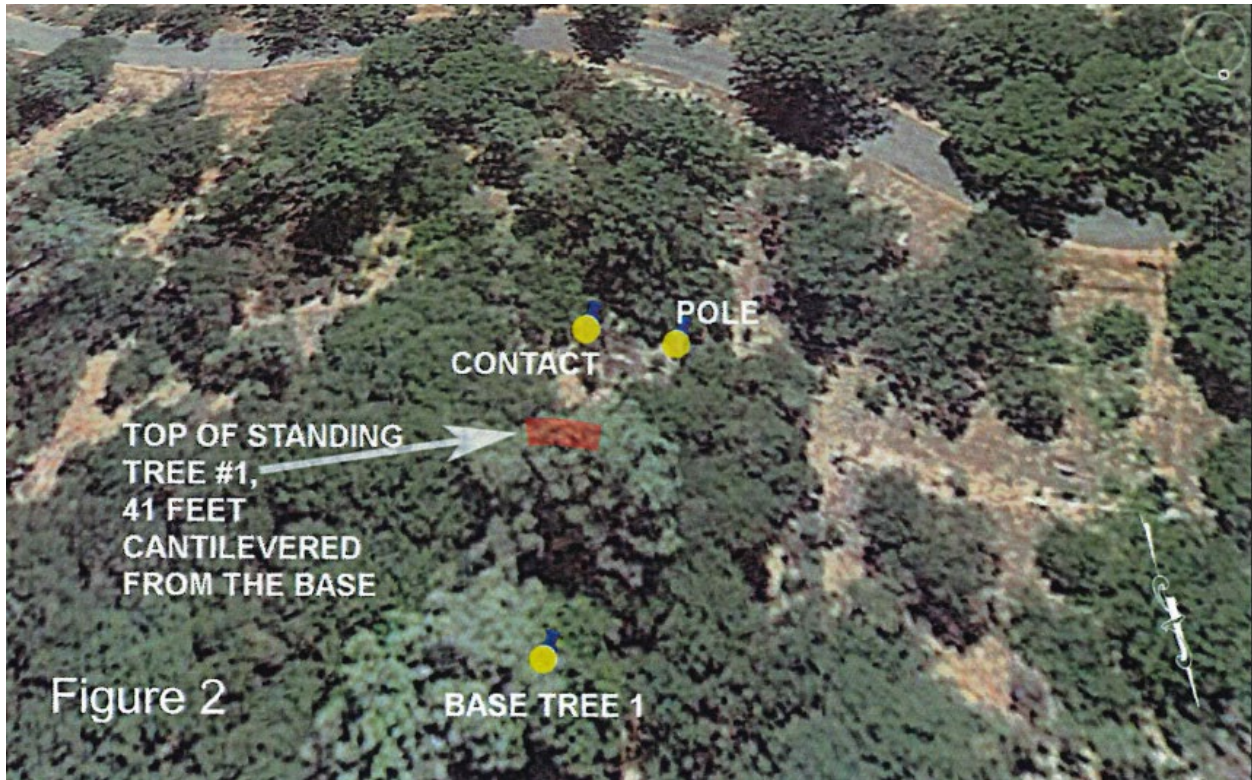
Figure 9: Diagram of Subject Tree, point of contact, and Pole from the Vegetation Analysis.⁴⁶

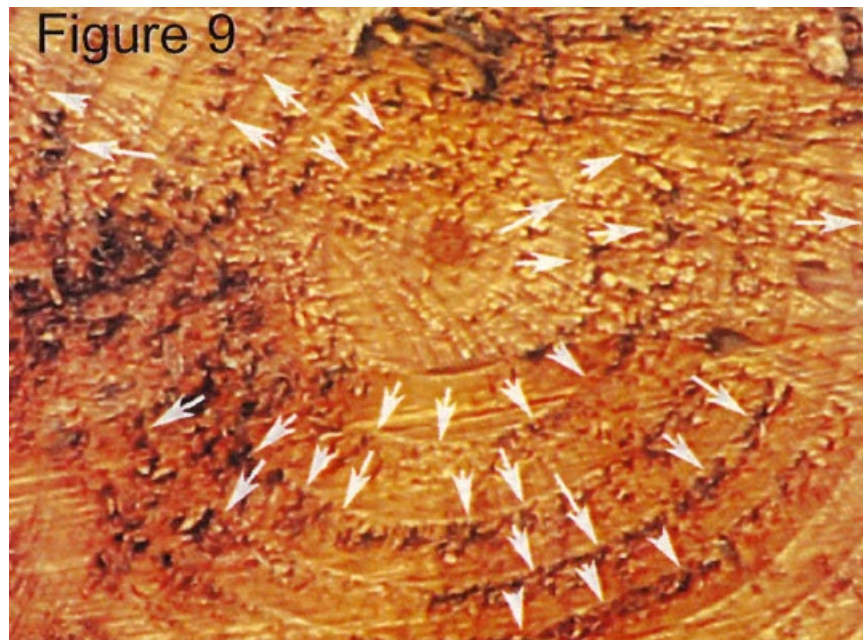
Figure 15: Pulled out Fibers on Trunk⁵⁹
