San Francisco Gas Event

Raymond Thierry
Pacific Gas and Electric Company
6121 Bollinger Canyon Road
San Ramon, CA 94583

Exponent, Inc.
149 Commonwealth Drive
Menlo Park, CA 94025

February 2018

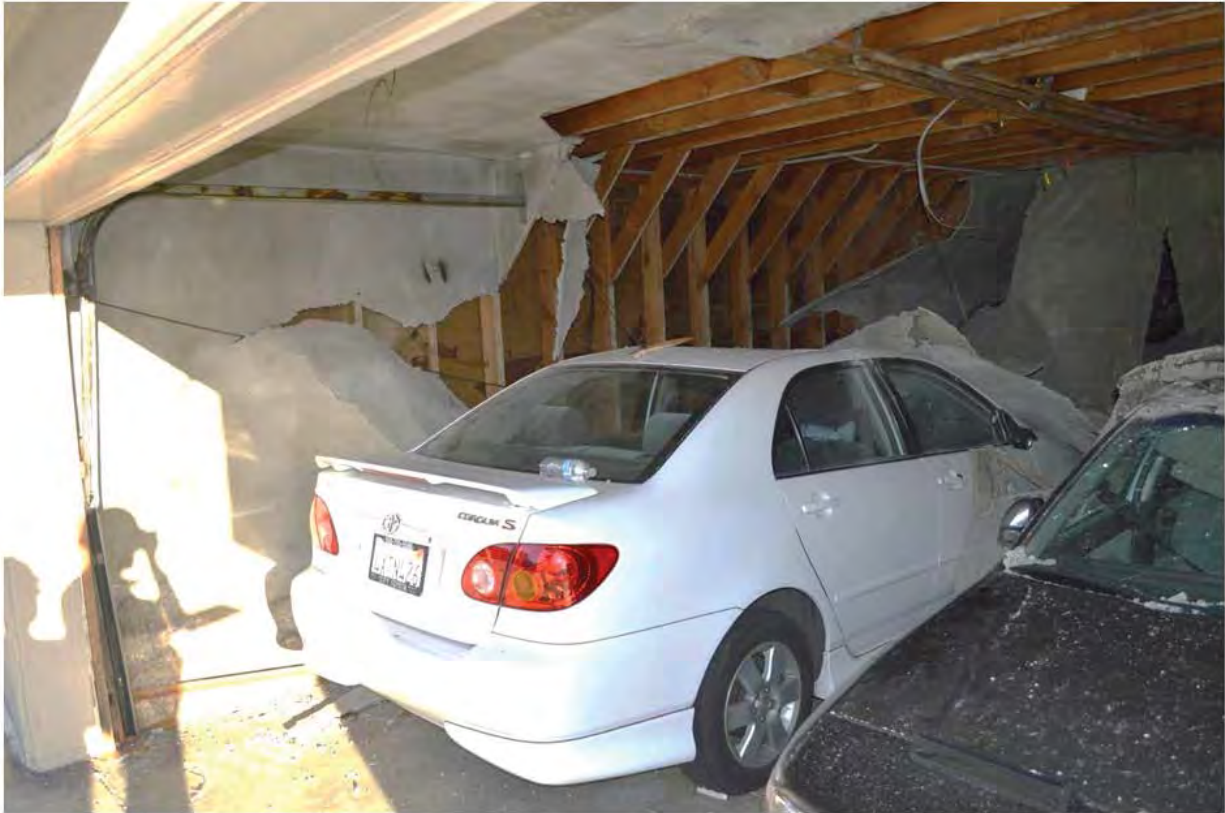
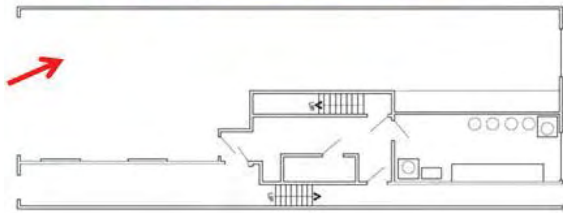
Figure 8. North side of garage at incident house. Photo taken by Exponent on November 27, 2017.

The garage walls and ceiling were constructed of cement plaster on metal lath. Portions of the ceiling and wall plaster had collapsed near the front of the garage and damaged two of the automobiles parked in the garage. The ceiling plaster that fell down broke the windshields and crumpled the roof sheet metal of the two automobiles parked in the front of the garage. The damaged walls and ceiling in the garage are shown in Figure 7 through Figure 9. There were signs of thermal damage to the paper lining behind the wall studs on the north side of the garage, as shown in Figure 9. The rear (east) of the garage, shown in Figure 10, showed no signs of thermal damage, and the walls showed no signs of damage. The glass window at the rear of the garage was broken. The floor joists above the garage showed no signs of thermal or structural damage. The floor boards in Apartment 1 above the garage were visible from the

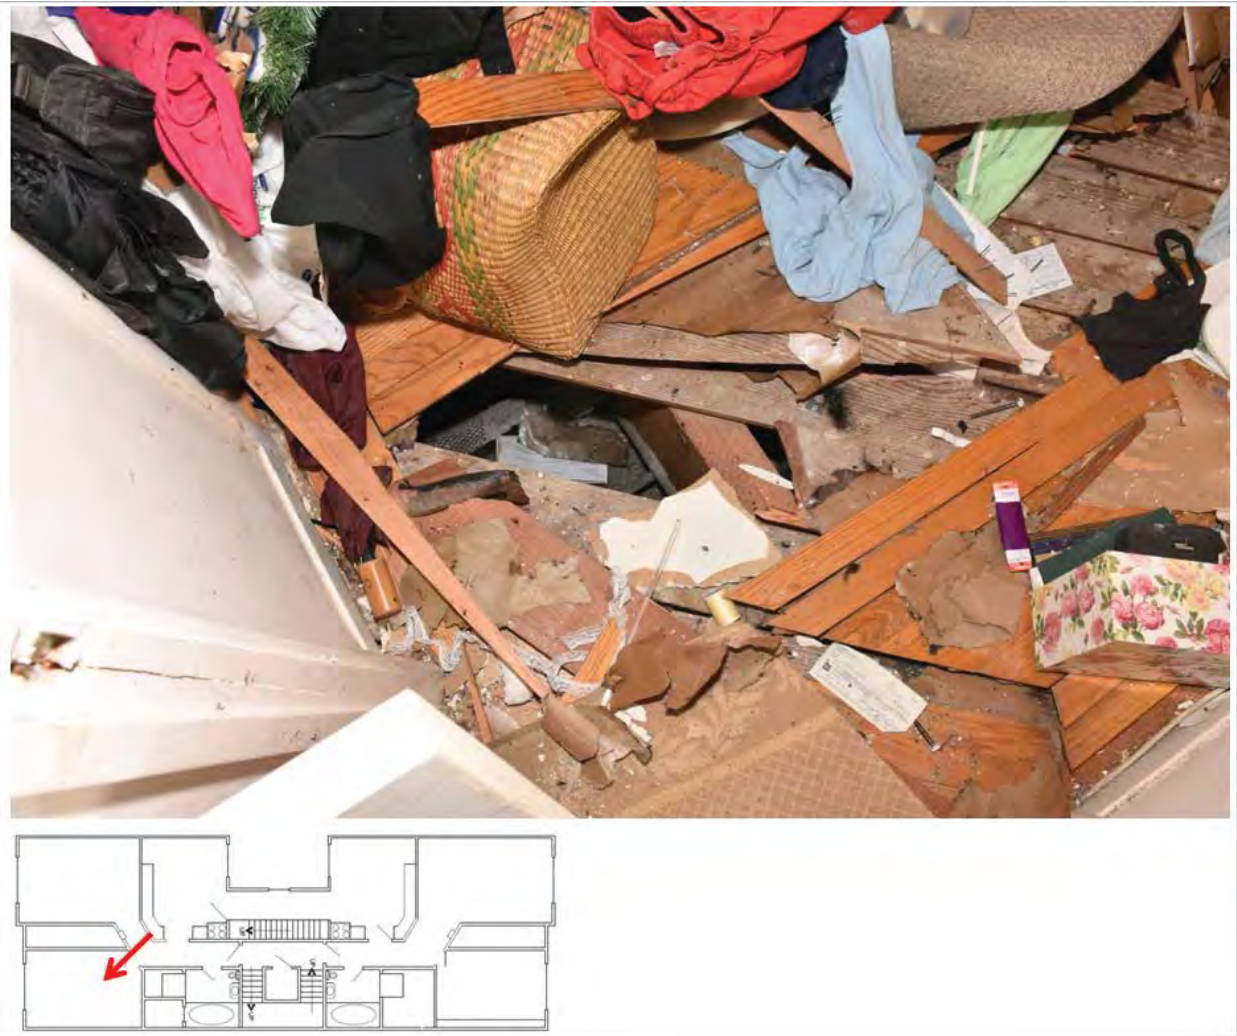
Figure 14. Bedroom floor in Apartment 1. Photo taken by Exponent on December 1, 2017.

Apartment 1 showed significantly more damage than Apartment 2. The bathroom door in Apartment 1 was broken in, as shown in Figure 13. The bathroom exterior window was also broken as shown in Figure 13. The kitchen floorboards in Apartment 1 had been pushed up and were observed to be loose. The kitchen exterior window was also broken. The most severe damage in Apartment 1 was concentrated in the front of the apartment near the bedroom and living room. The floor in the bedroom had been severely damaged, and the floorboards were dislocated and scattered. The damage to the bedroom floor is shown in Figure 14. The living room in Apartment 1 showed very severe damage to the floor. The floorboards had been dislocated and scattered, and in some locations only the floor joists remained. The furniture in the living room had been displaced and upended. The living room is shown in Figure 15. The

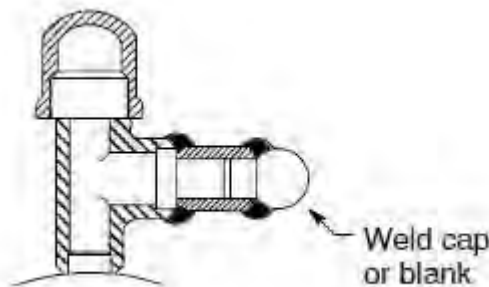
Figure 30. Figure 7 from GS A-93.2 showing a properly deactivated Mueller tee with a welded cap.

The incident service stub, which once provided service to [REDACTED] was found cut downstream of the Mueller tapping tee, and neither the stub end nor the near end of the abandoned service line was capped. Per the recommendations of Gas Standard A-93.2, both cut ends of the pipe should have been capped and a protective sleeve should have been installed on the remaining stub. The incident service line had a pressure-containing cap on the far end (near the 6-inch plastic main) but did not have a cap on either the stub or the end of the abandoned service line near the 6-inch steel main. A figure from GS A-93.2 (shown here in Figure 29) illustrates a properly deactivated Mueller tee with a steel-to-plastic transition fitting. A pressure-containing end cap and sleeve, such as that shown in Figure 29, was not installed on the incident service stub. Notice that unlike the service line deactivated by PG&E in 2003 (shown in Figure 22), the GS A-93.2 illustrates a cap at the end of the service stud and a protective sleeve installed. The cuts that were made in the service line left less than 1.5 inches

of plastic pipe remaining on the end of the stub. This is not enough plastic pipe to attach a mechanical end cap or a fusion end cap. GS A-93.2 permits the stub to be sealed with a cap welded on the steel pipe, as shown in Figure 30. A steel cap was not attached to the end of the incident stub.

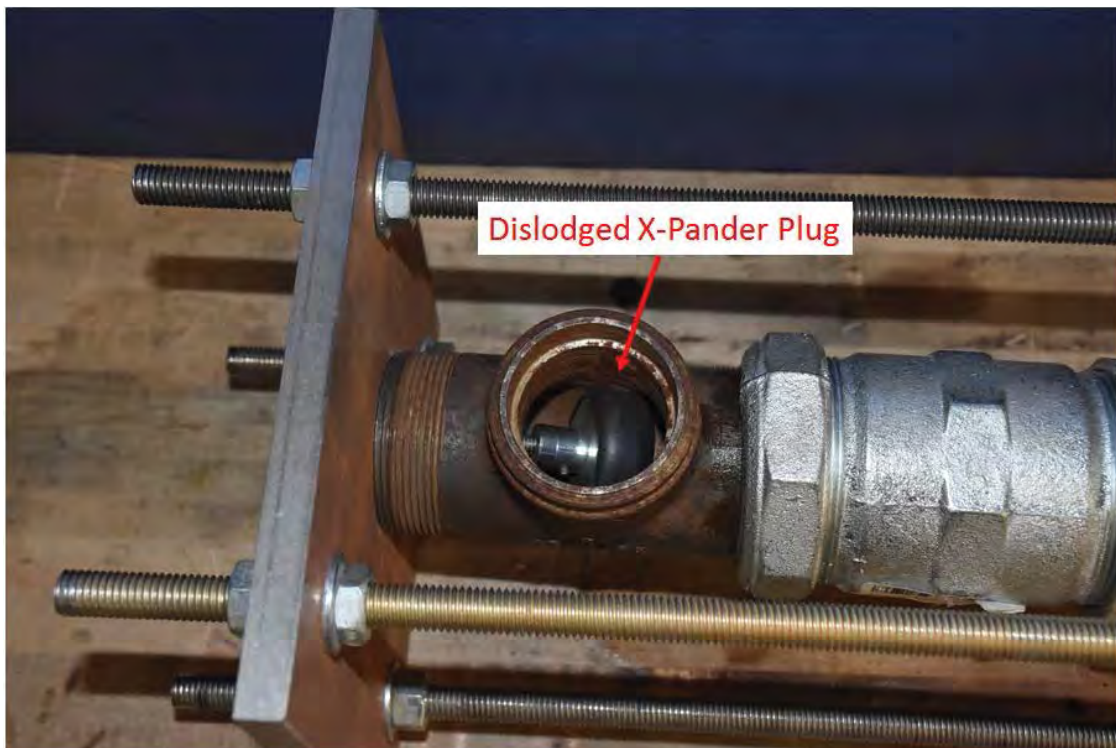
Figure 40. X-Pander plug pressure test apparatus with dislodged plug.

A clean pipe assembly and a new set of plugs were used for testing. After being installed, the plugs sealed well, as long as they remained in their installed position. However, during many of the tests, the air pressure was increased to a high enough level that the plug became dislodged, at which point it would release its seal with an audible popping sound. After that, air freely flowed through the unsealed apparatus and the test would be stopped.

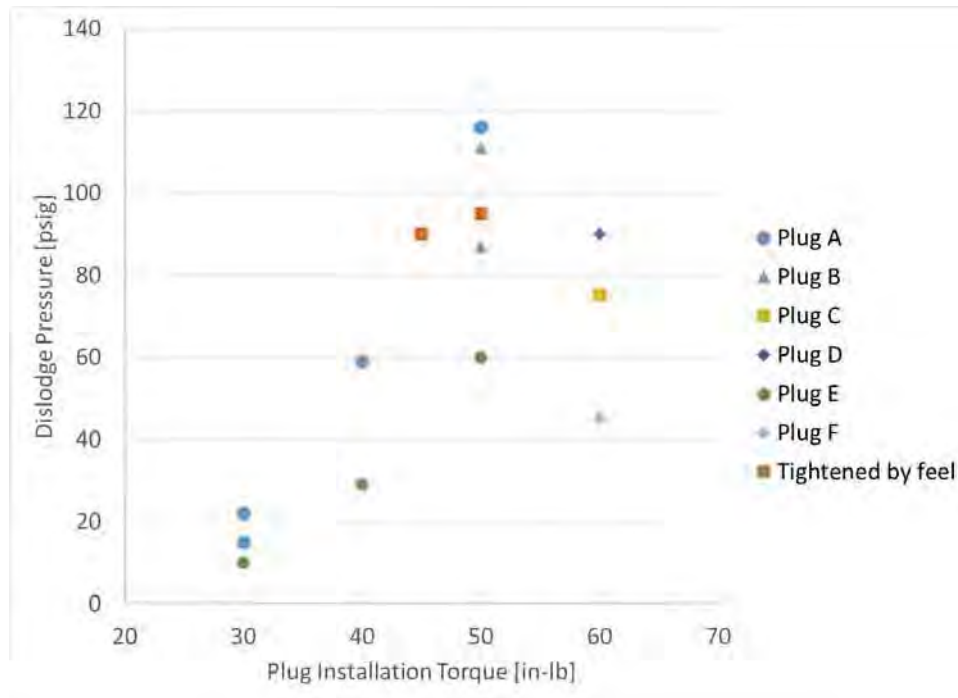
Figure 41. X-Pander plug installation torque vs dislodge pressure results.

- a. A plug held 11 inches of water column (WC) for a period of an hour with no signs of leaking and without dislodging.
 - b. When the pressure was increased rapidly, the plugs dislodged at pressures that ranged from 15 to 116 psig. The pressure required to dislodge the plugs depended on the torque that was used to install them.

Many of the plugs were tested more than once, and multiple data points are shown in the same bullet symbol and color on Figure 41. Six of the plugs (Plug A to F) were tightened with a torque wrench to 30–60 in-lb, as indicated in the figure. One of the plugs (tightened by feel) was tested twice after being tightened by two different people to what they felt was “tight.” The installation torques listed for the “tightened by feel” tests was estimated based on the number of visible threads on the installed plug and an established relationship (pre-test calibration) between the number of visible threads and the tightening torque.

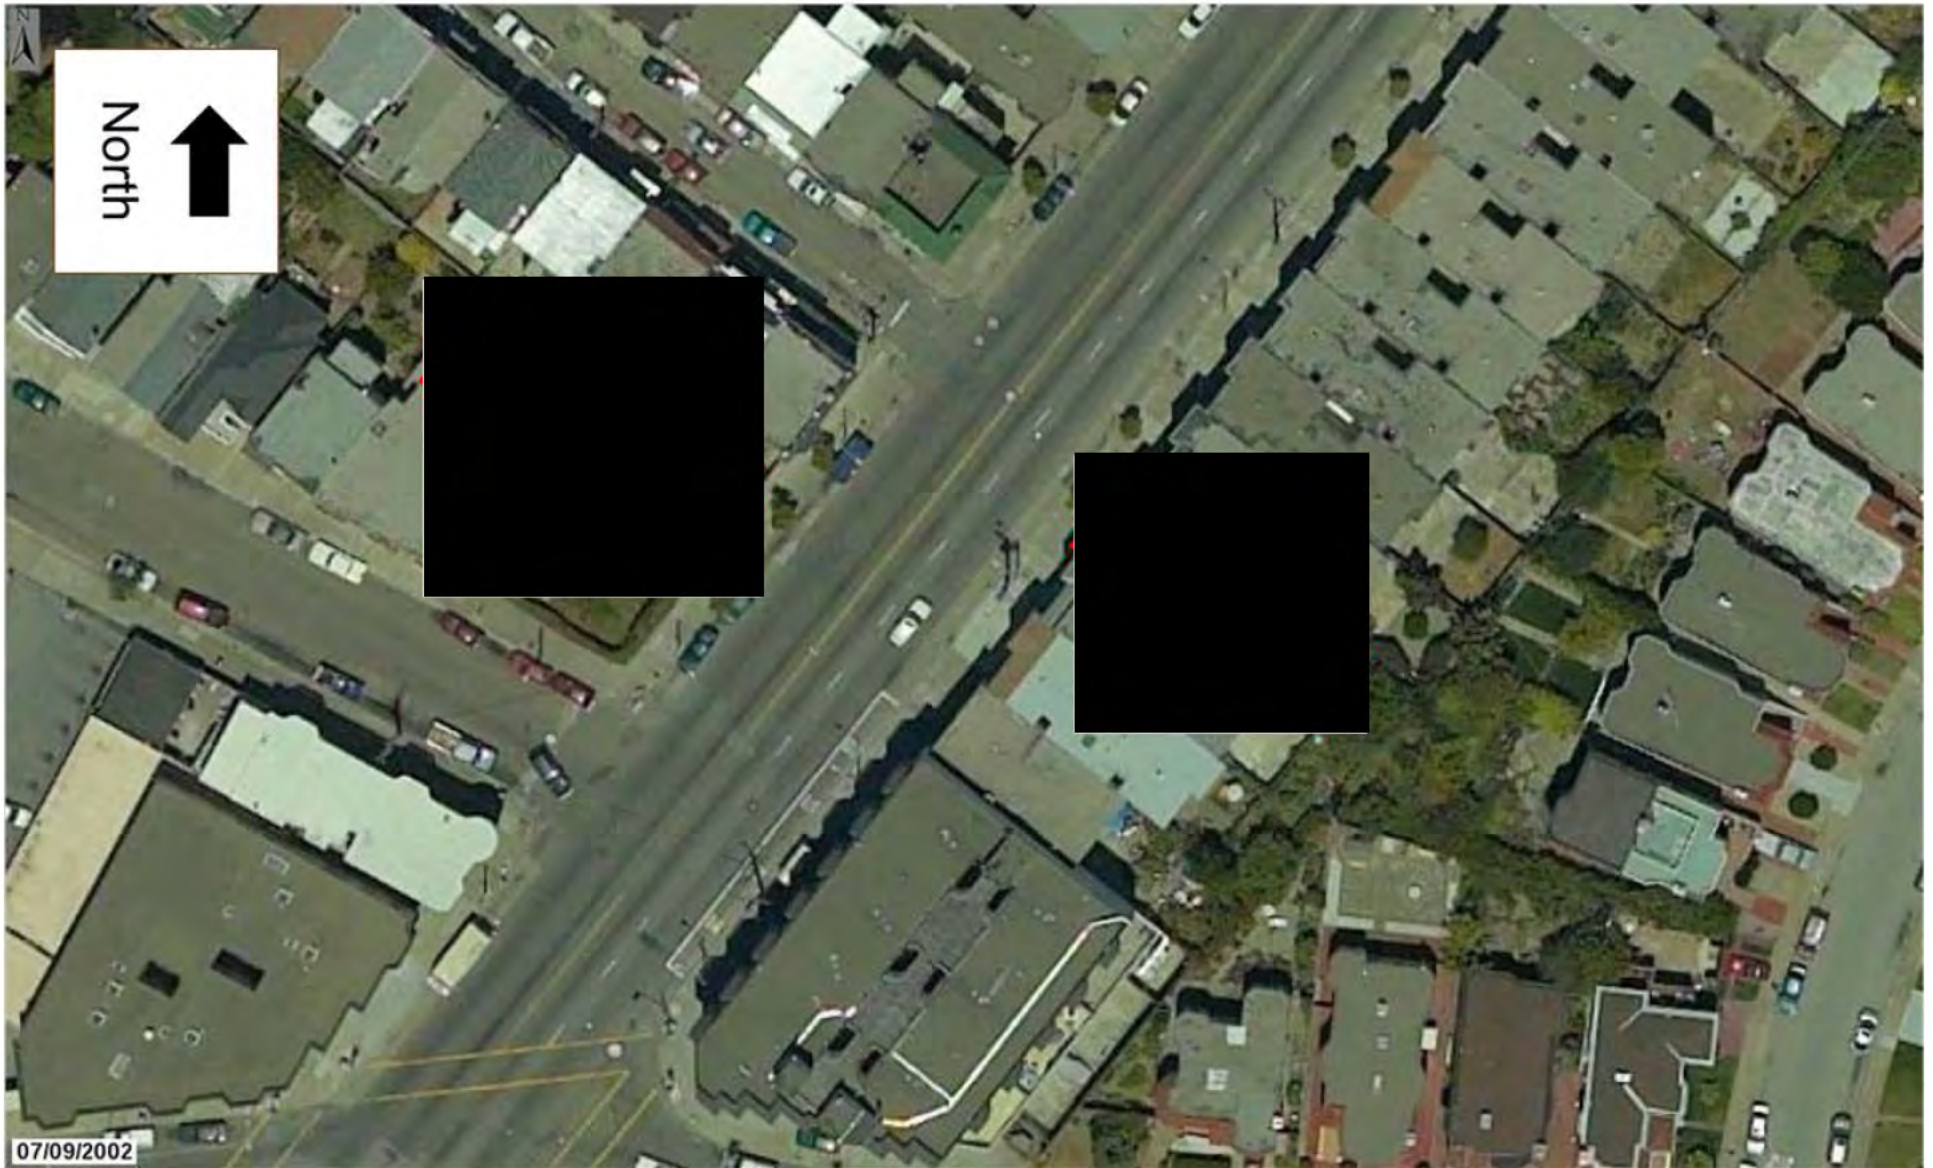
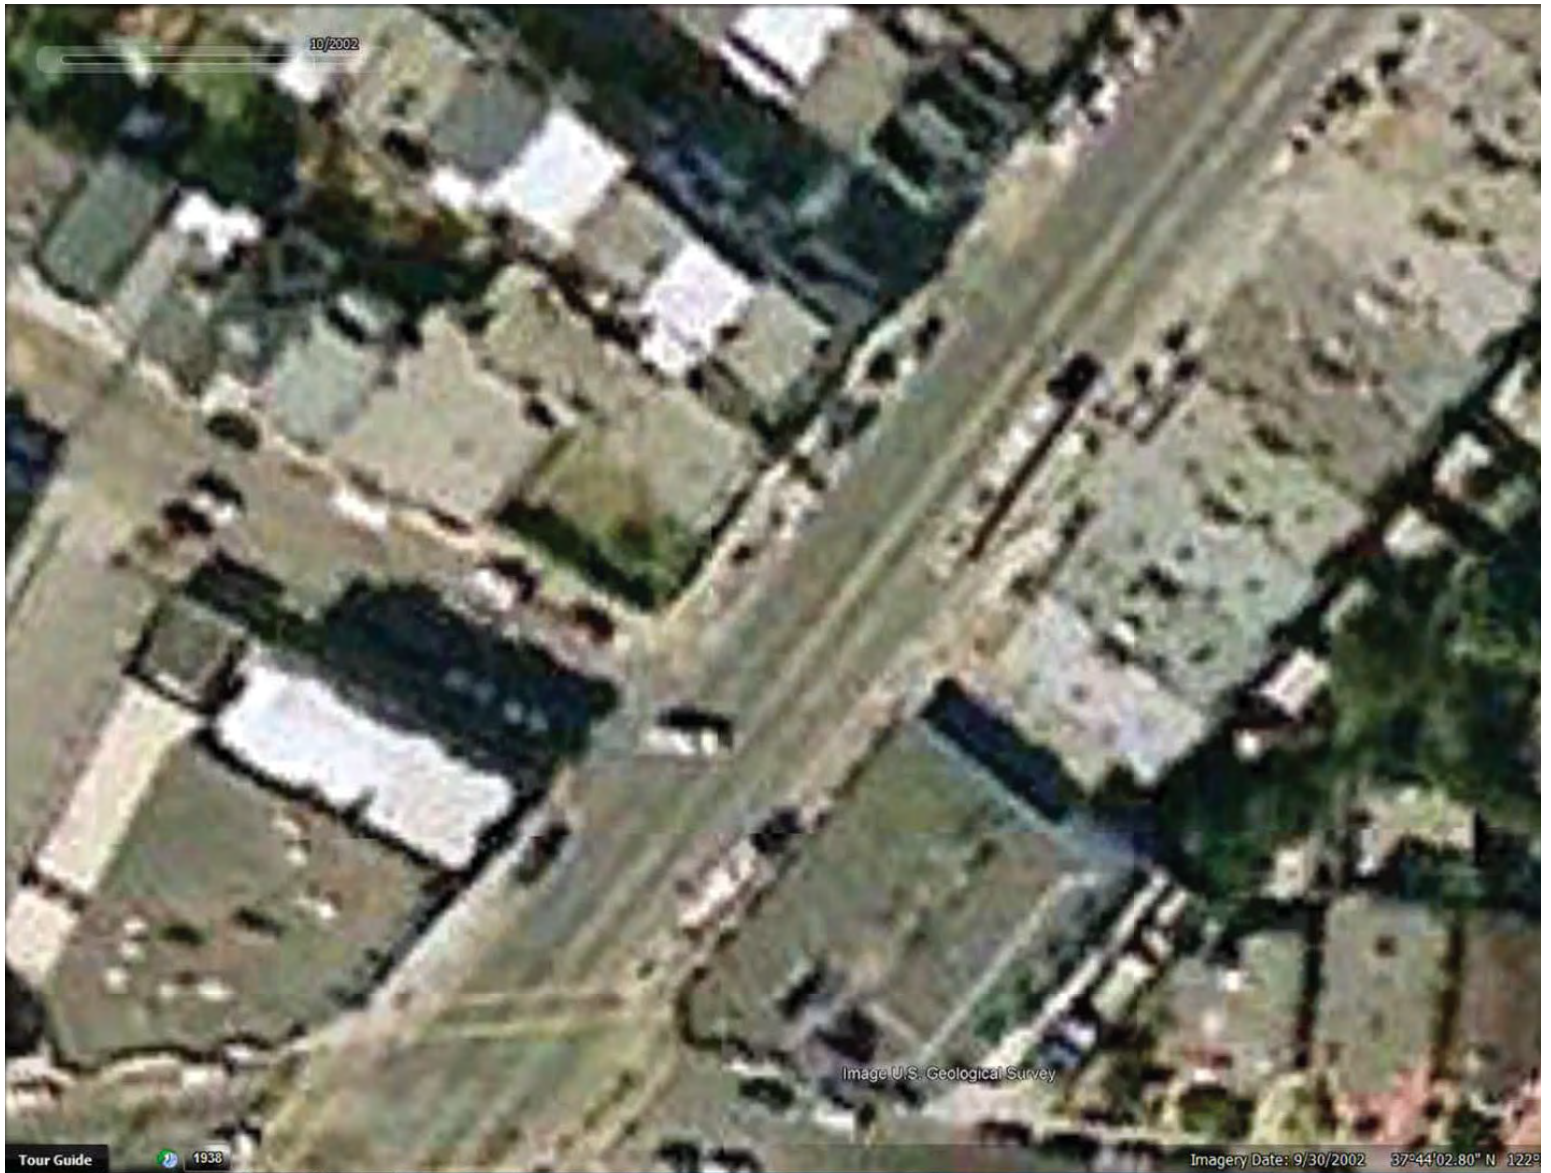
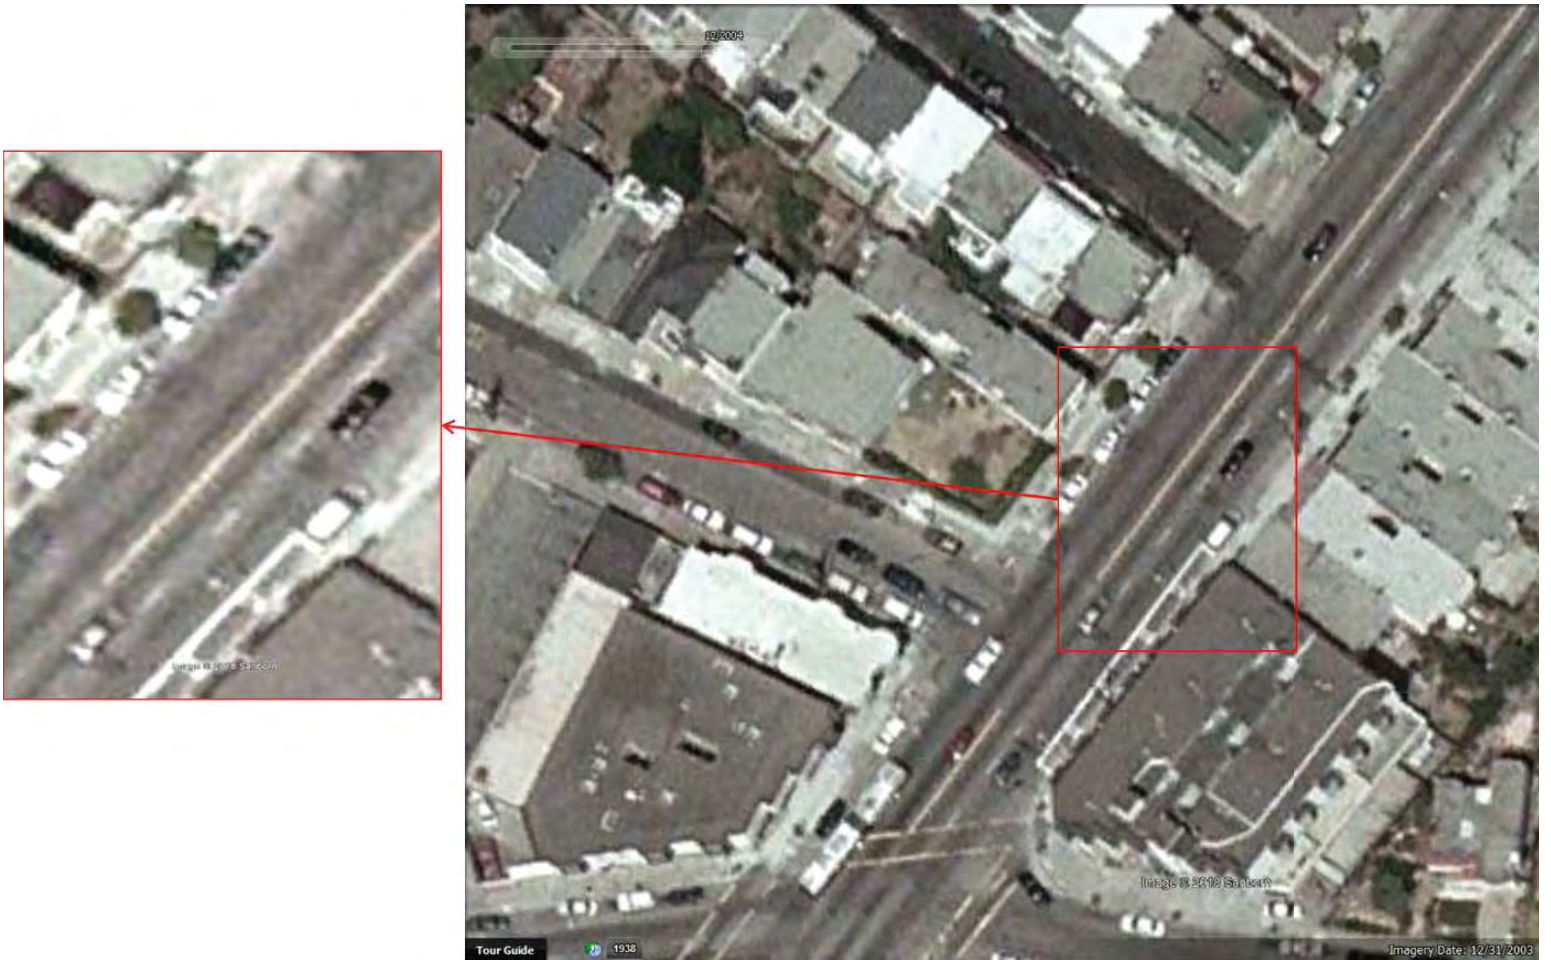
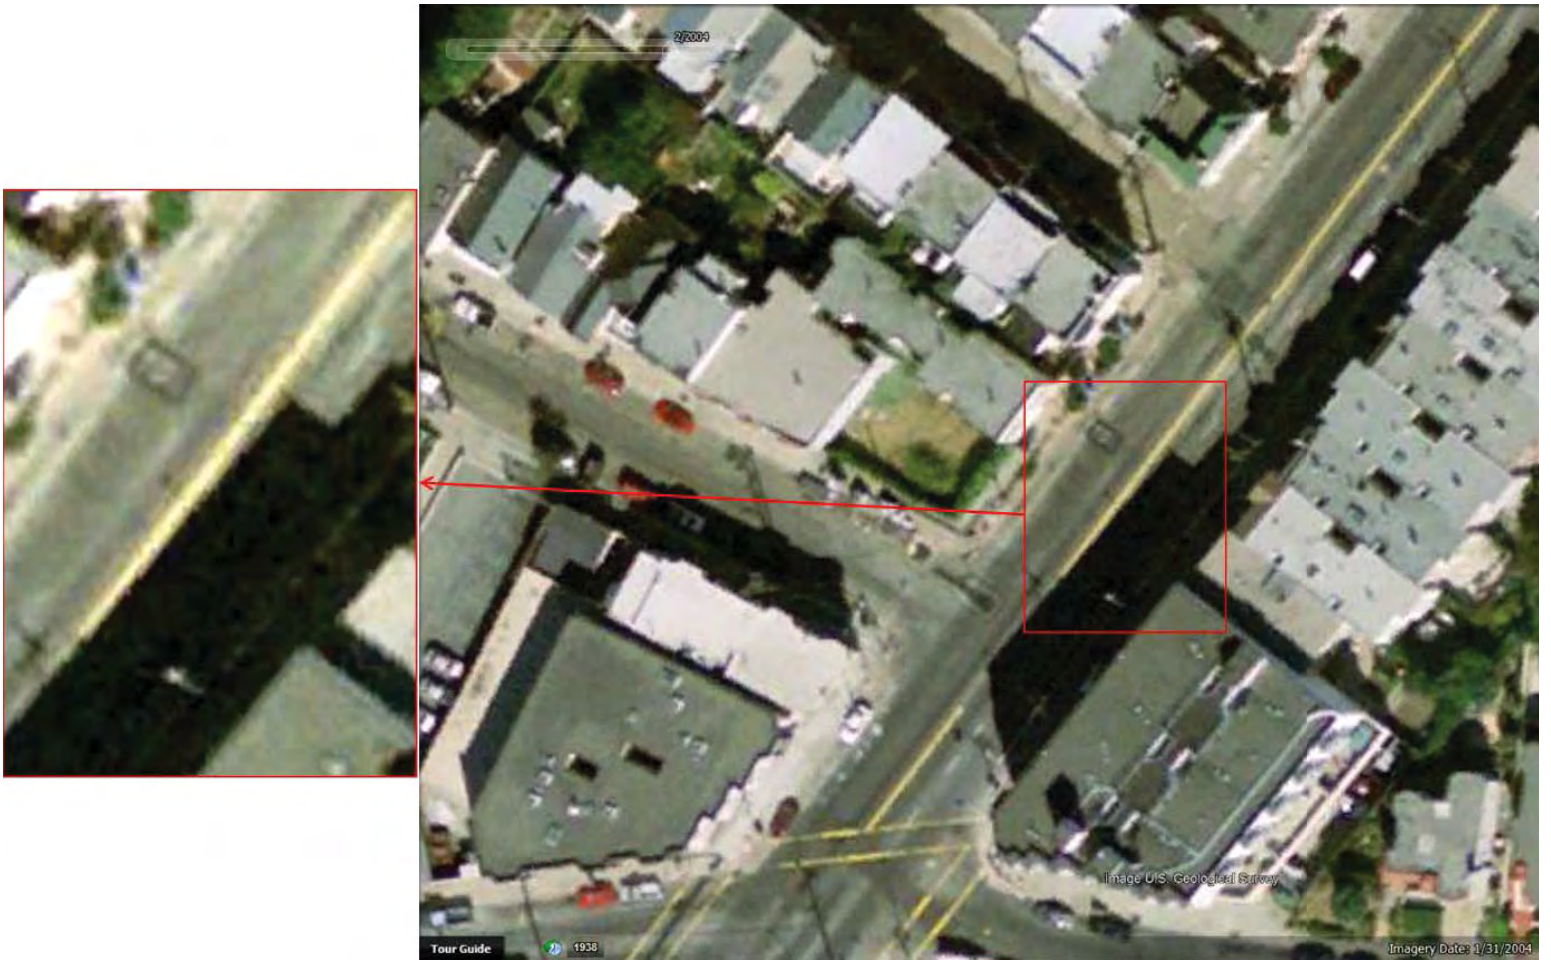
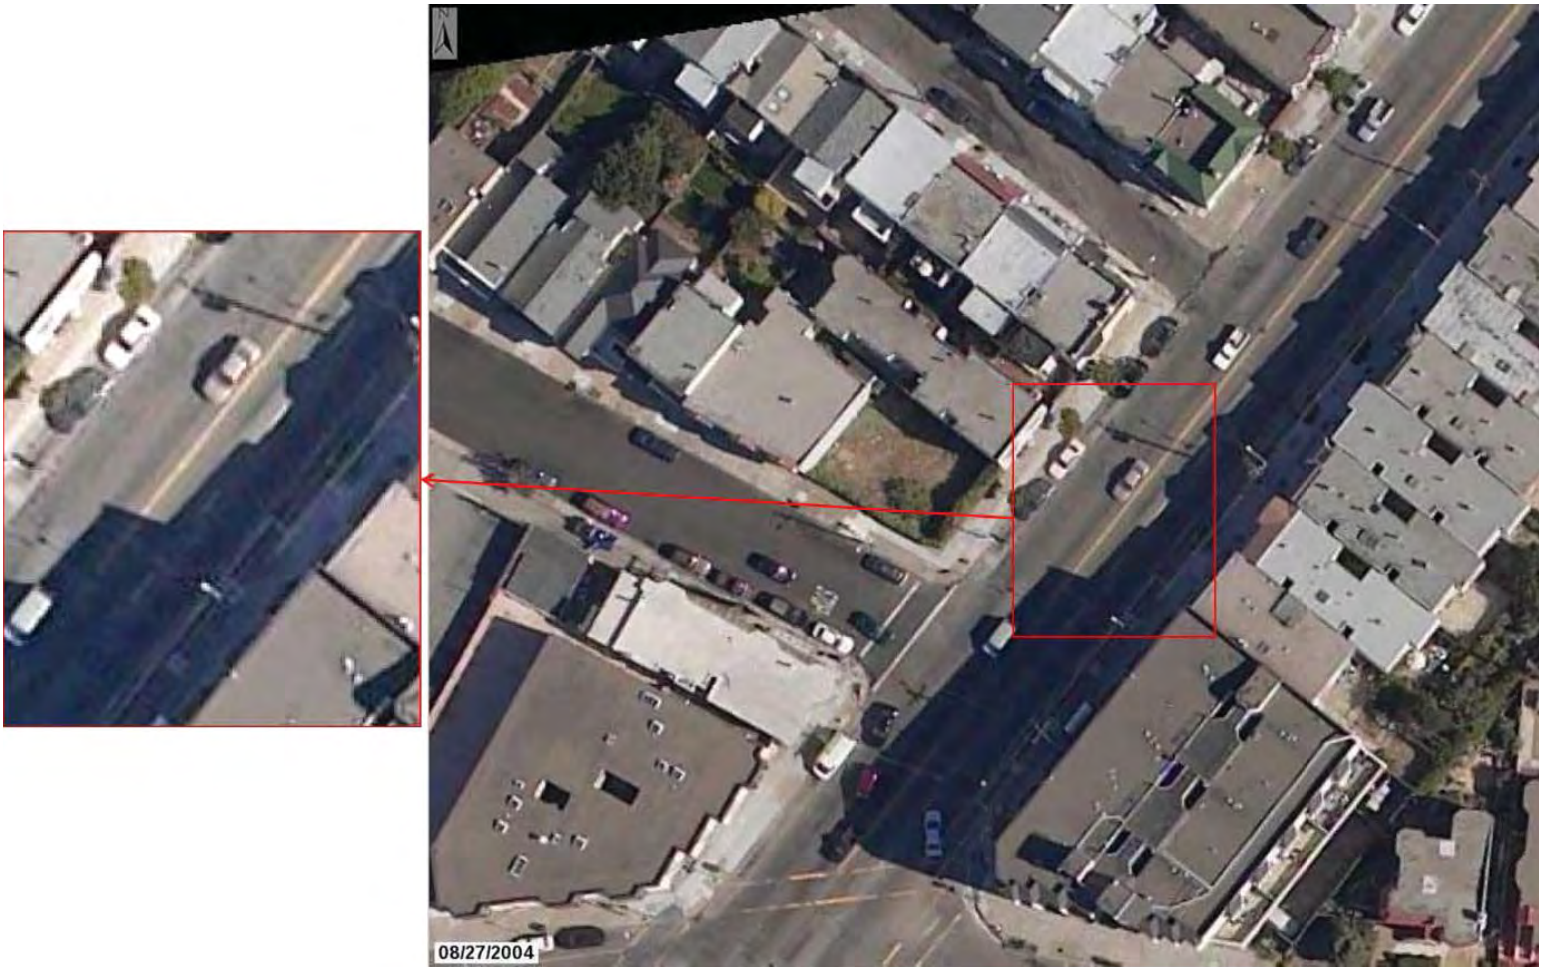
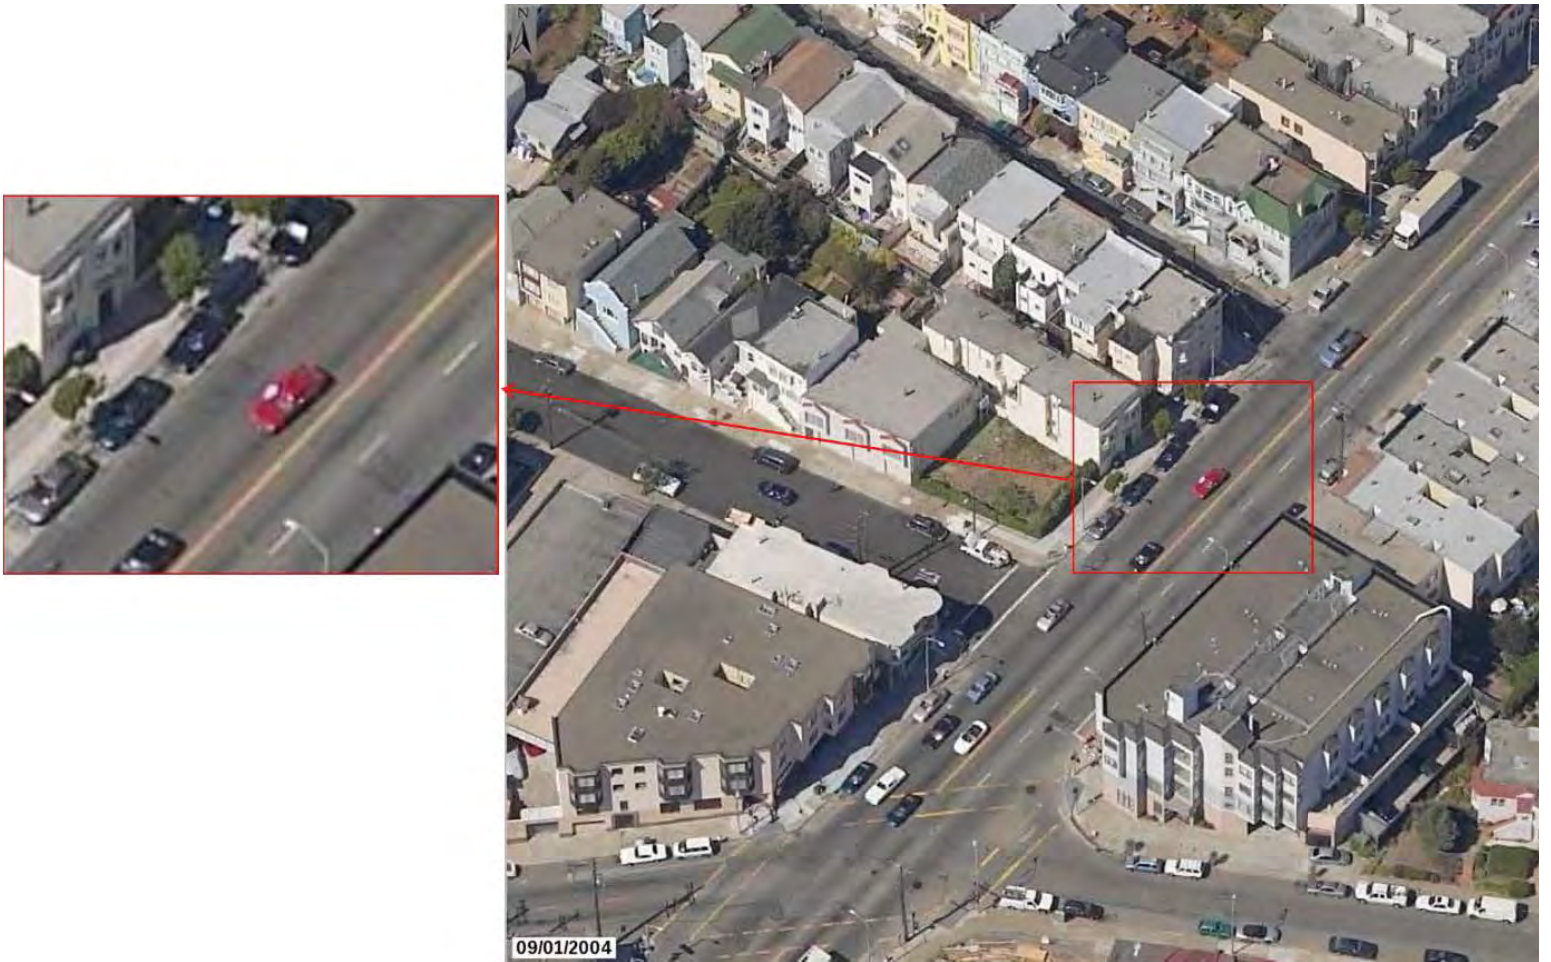
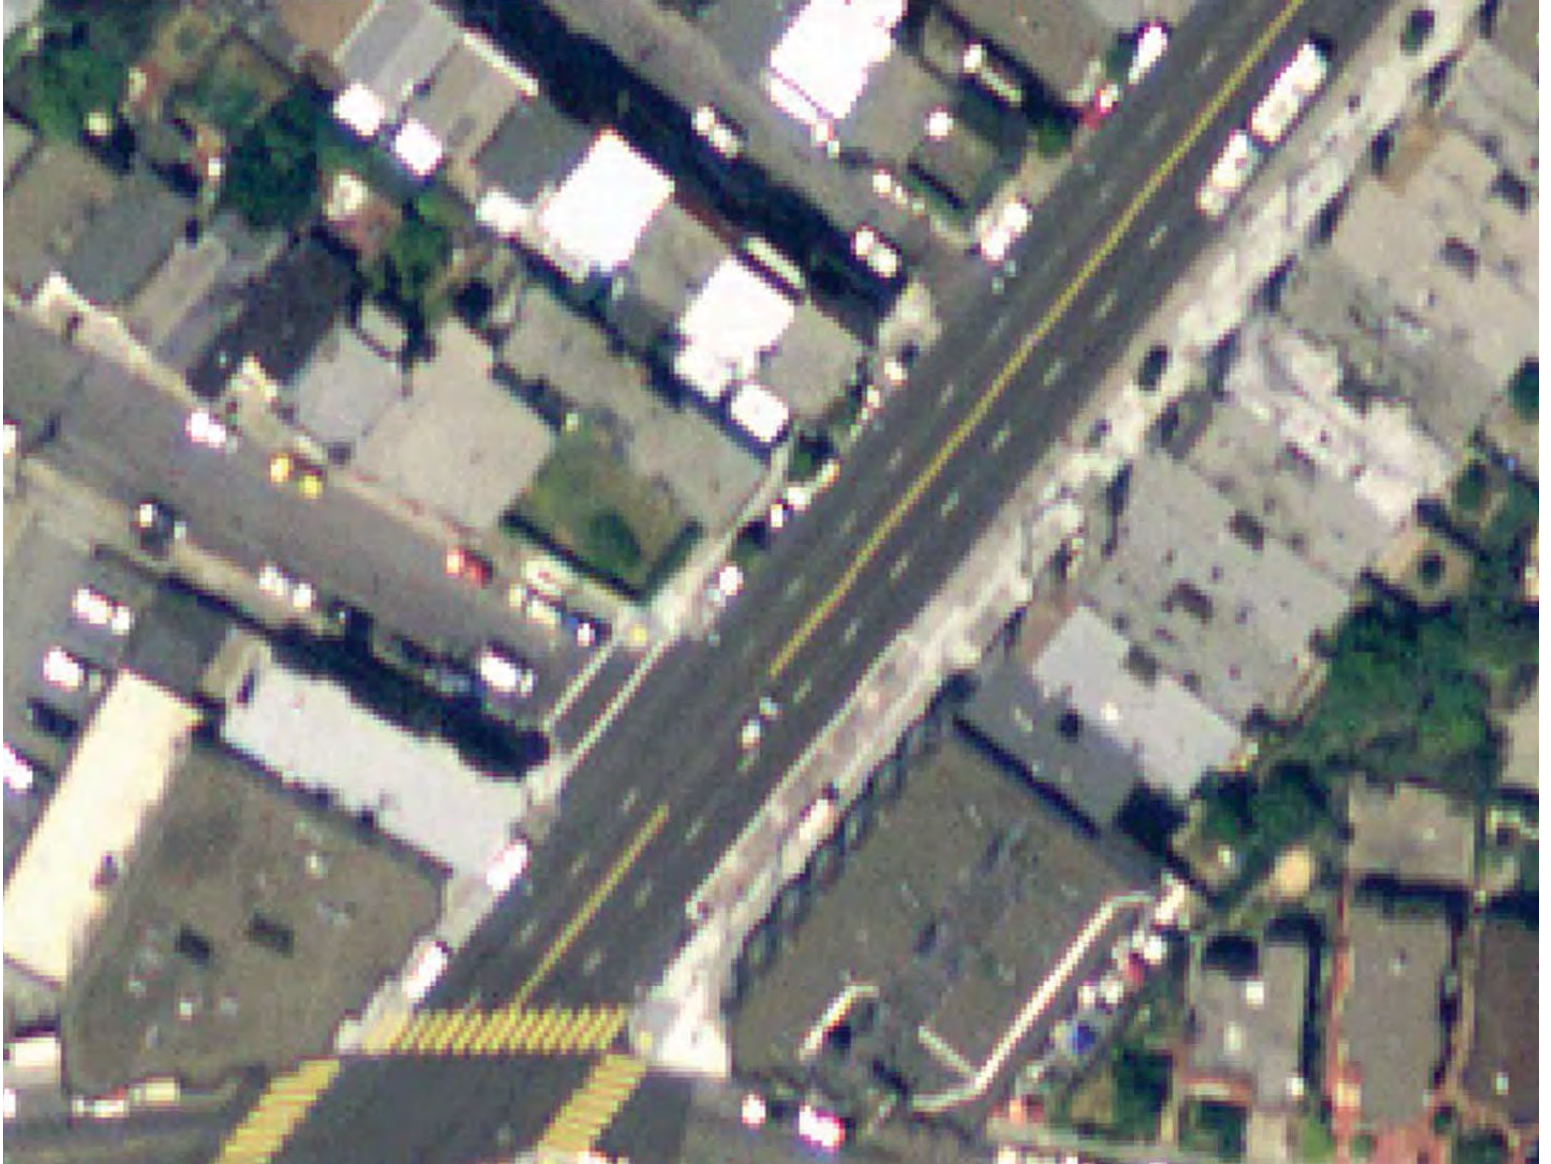
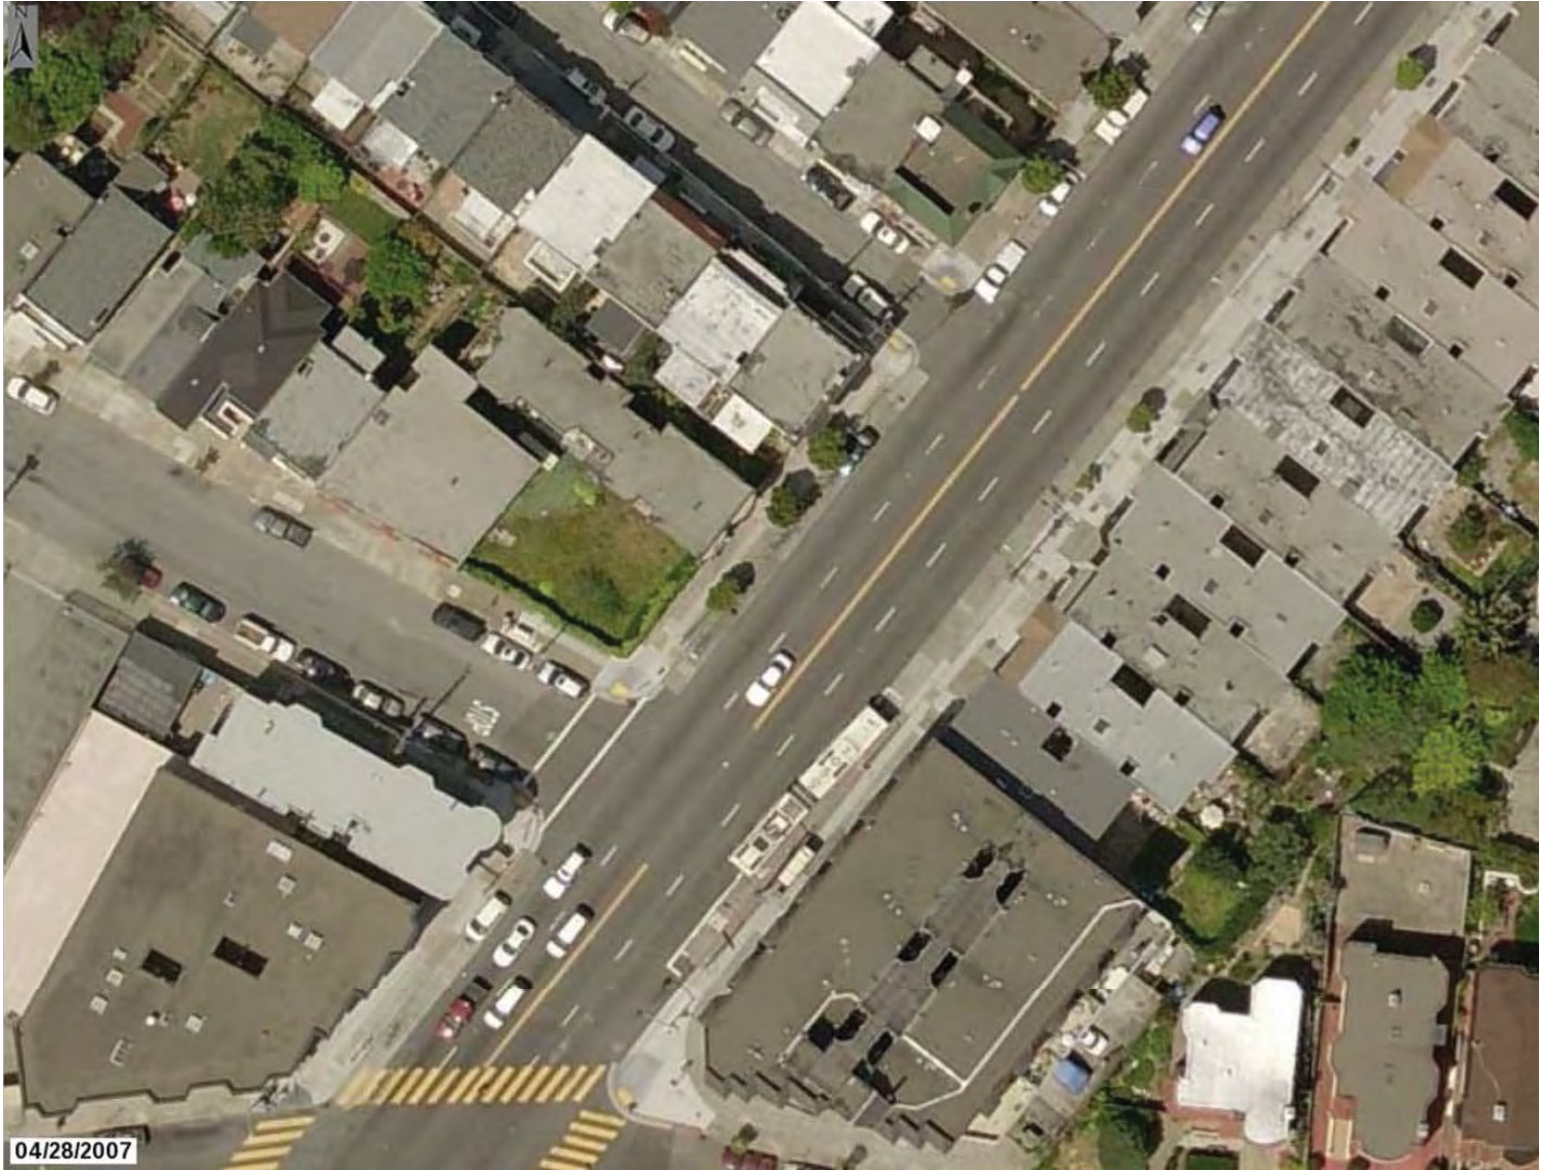
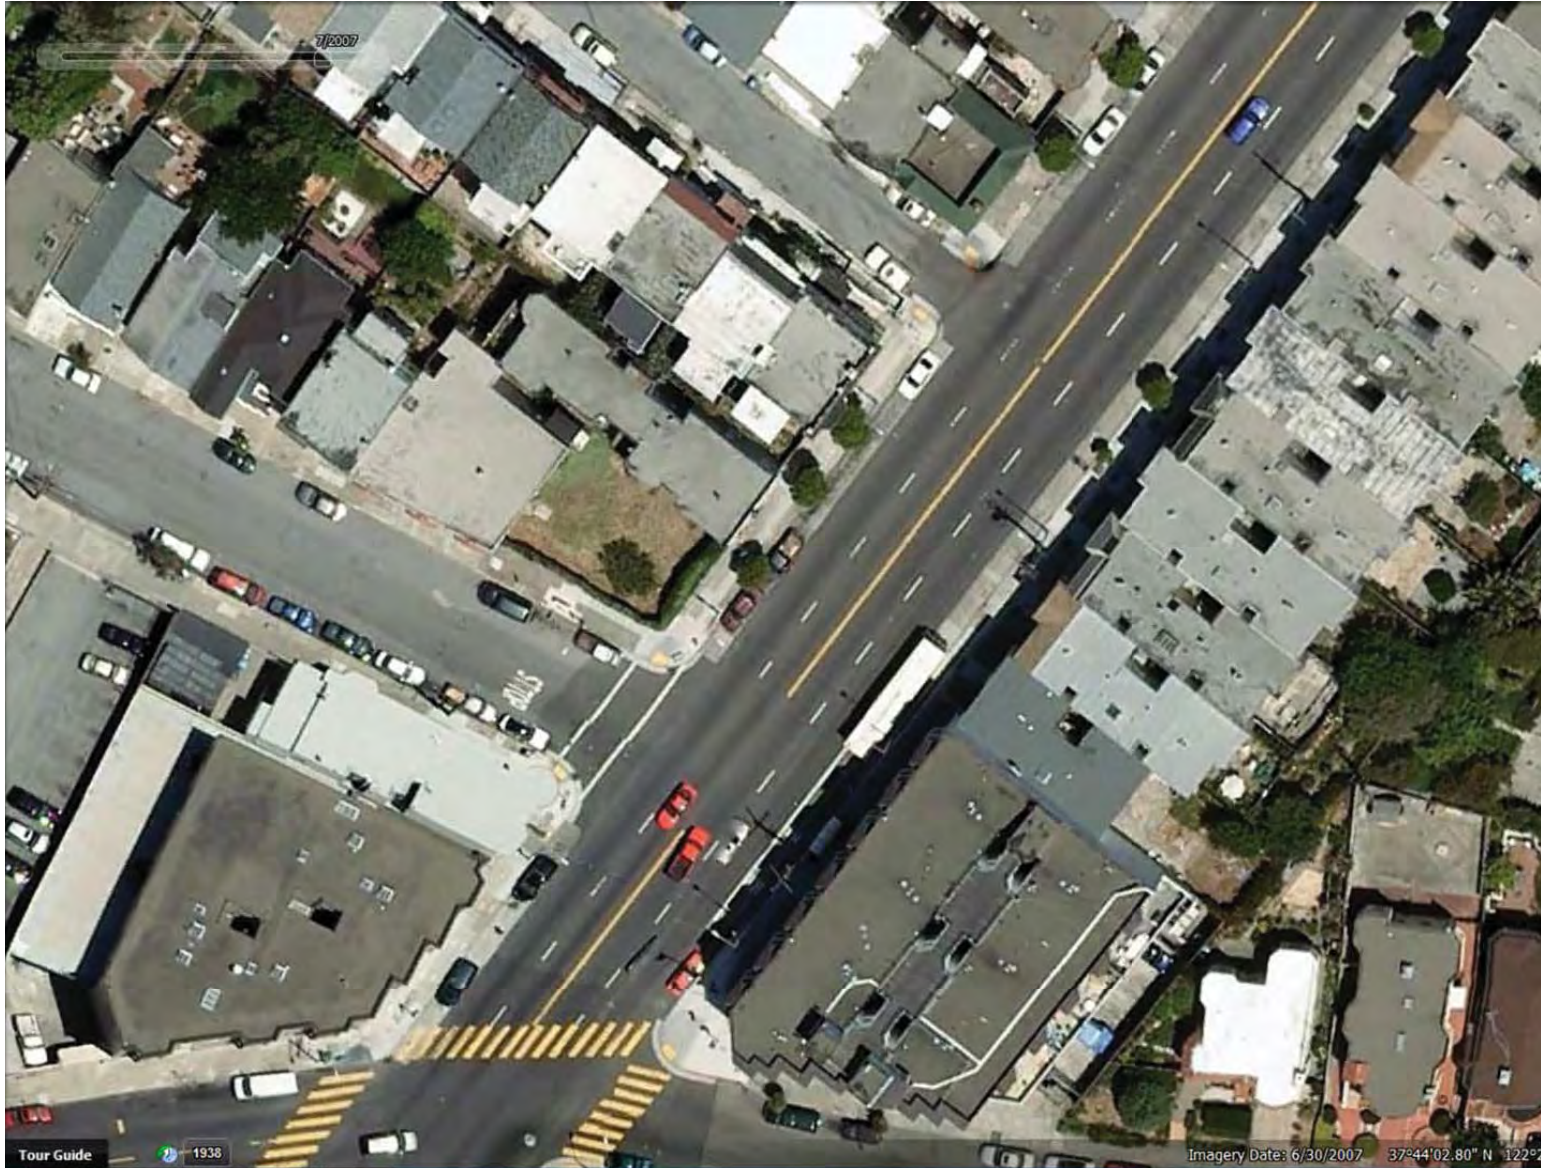
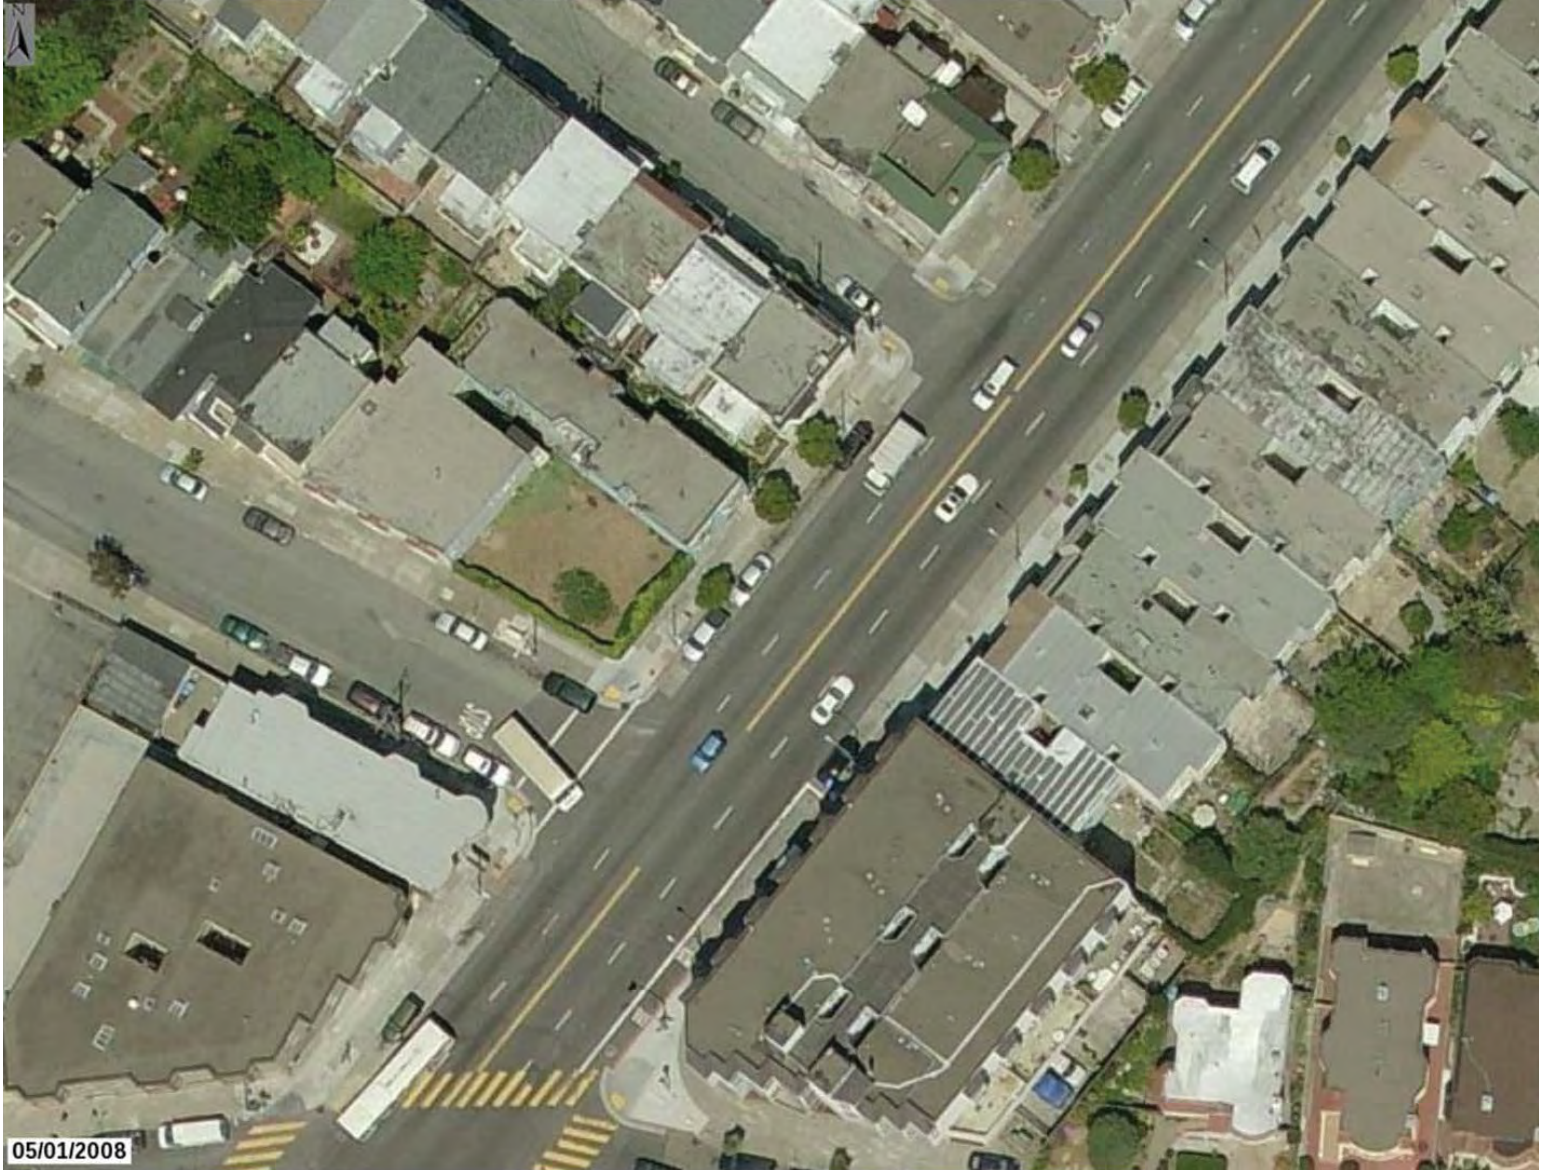
- e. Historical aerial photos show that the only fresh pavement visible at the leak location appeared in the late-2003/early-2004 timeframe. Therefore, it is unlikely that work was done in the immediate area of the service tee and uncapped stub between the time of the service transfer and the incident.
