San Francisco Gas Event

Raymond Thierry
Pacific Gas and Electric Company
6121 Bollinger Canyon Road
San Ramon, CA 94583

Exponent, Inc.
149 Commonwealth Drive
Menlo Park, CA 94025

February 2018

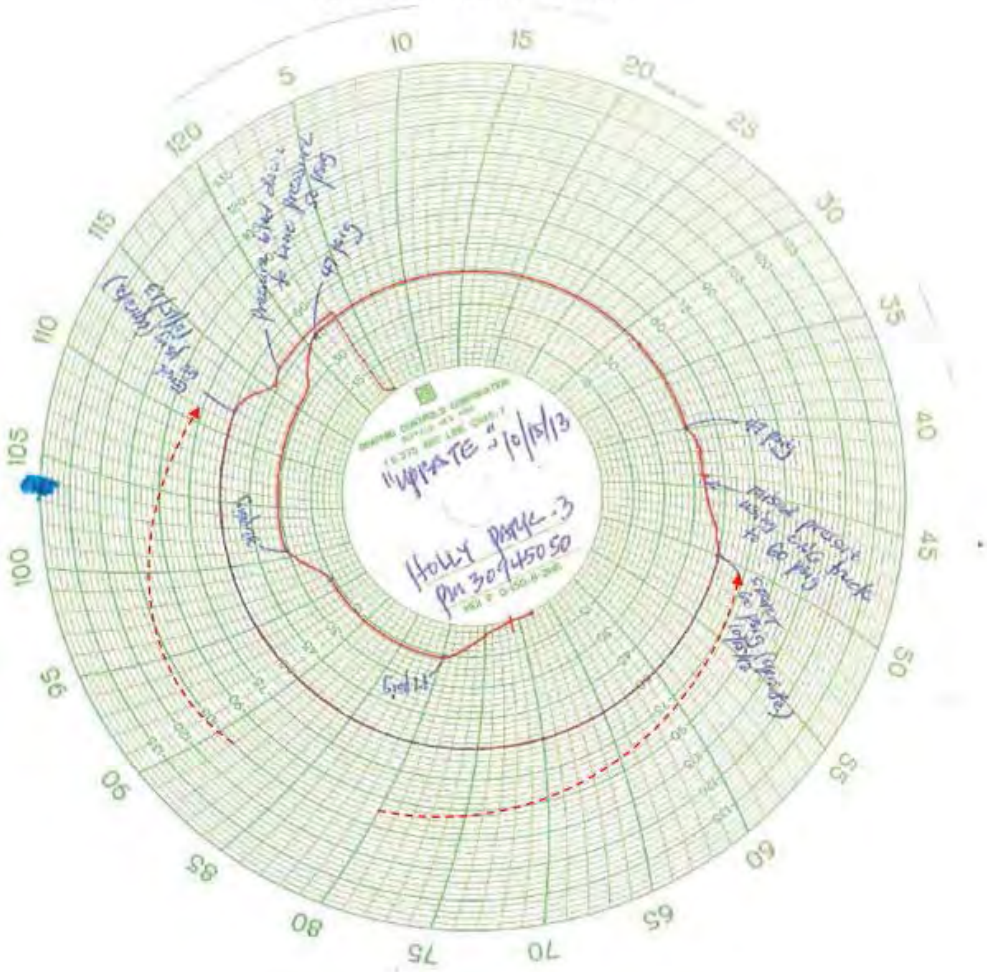
Figure 87. Front and back of pressure chart for uprate performed on job PM 30945050
