SIF Potential -Deer Park Incident

Root Cause  
Evaluation Report

Deer Park, CA

SAPN # 7034203

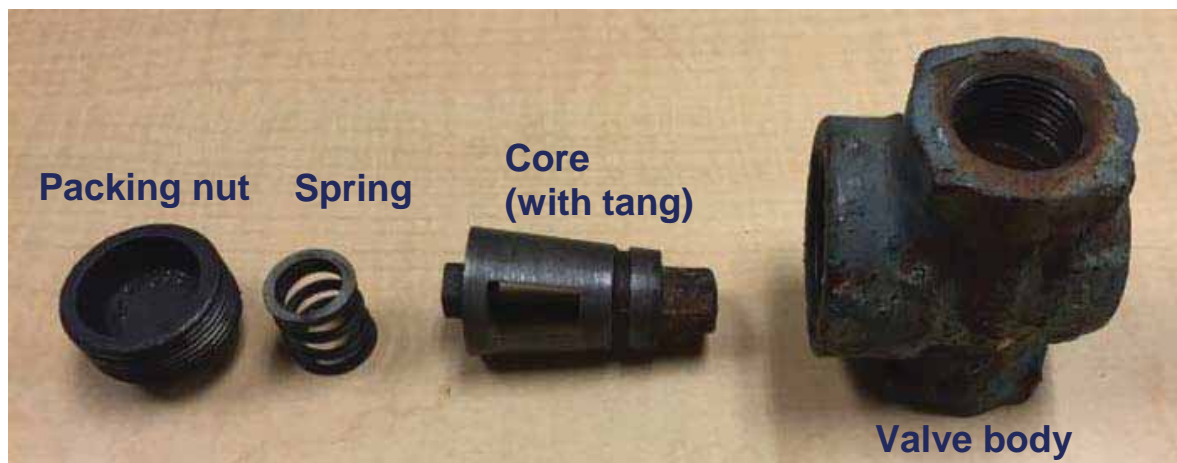
**Figure 3: Typical 3/4" Nordstrom Service Valve Components**

The 3/4" Nordstrom service valve is a plug valve that includes 4 components, the packing nut, spring, core and valve body, seen in Figure 3. The tang is a piece of the core that sticks out of the valve body and is the component that is used to turned the valve 90° to open or close the valve. A Nordstrom valve can become frozen or hard to turn. This can lead to damage to the tang when the valve is operated, potentially leaving a valve that cannot be shut off.
